SWEDISH COAST GUARD

Alpine Penelope Incident - 13 april 2022

Oil spill during Bukering operation

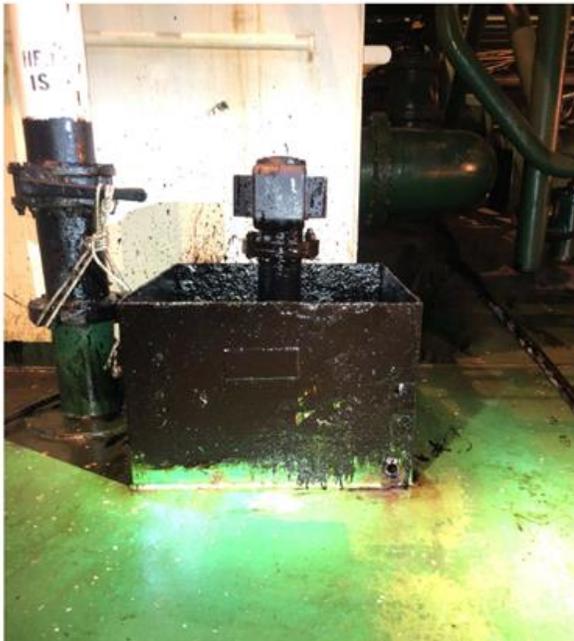
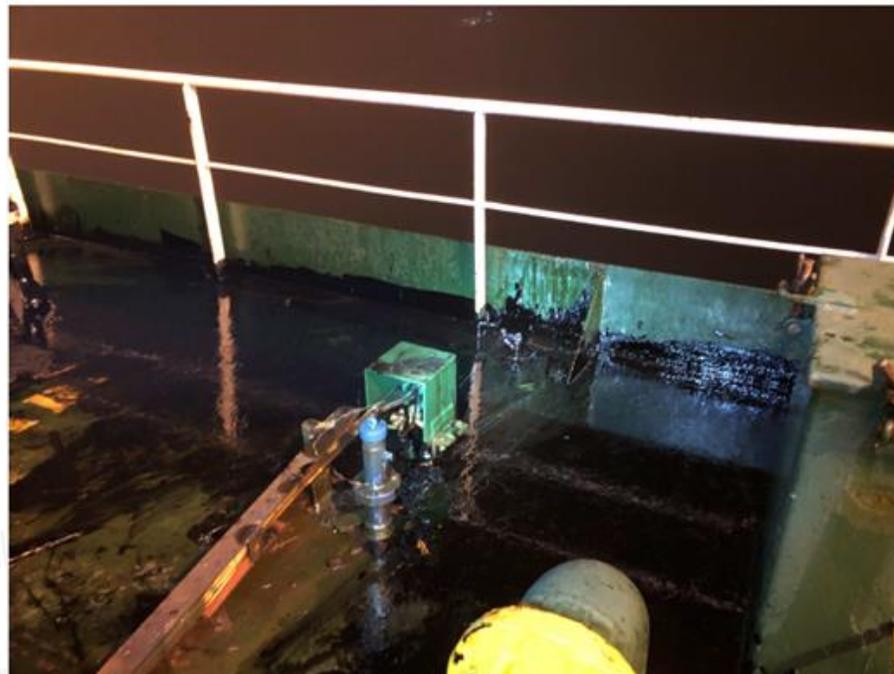
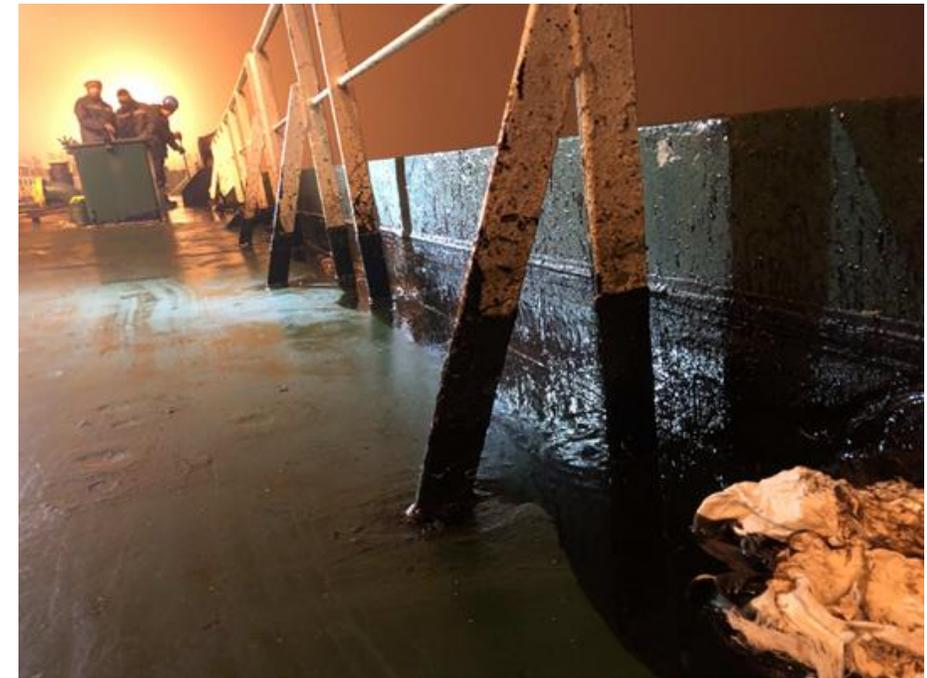
Initial information was that approximately 500 liters leaked on the deck but only 30-50 liters leaked into the sea from the tanker that received bunker oil.

Fotografier: Anslutningsventil som orsakat överbunkning, 2022-04-15 09:22, id: 0000-1123-22

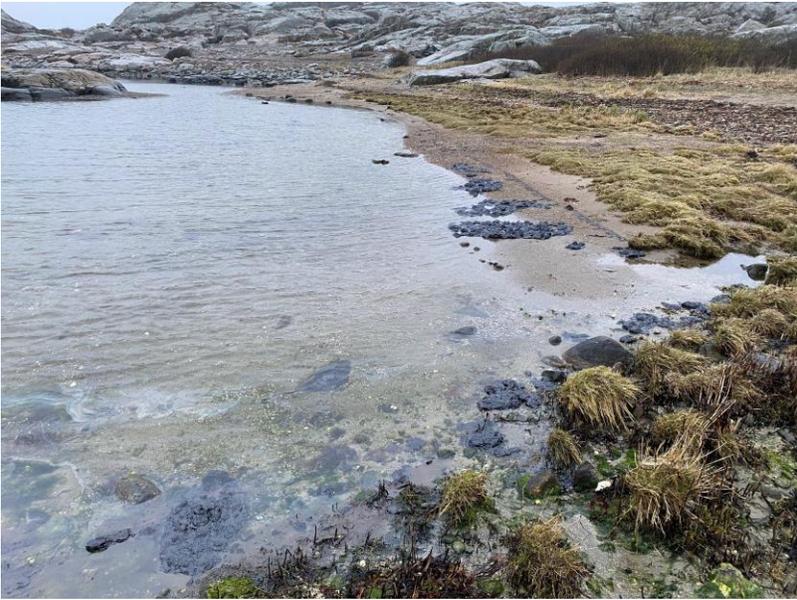
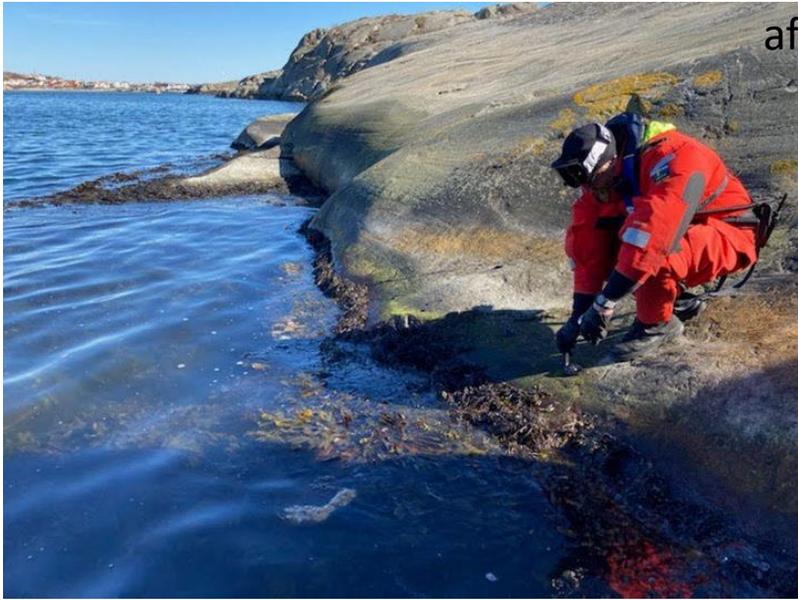
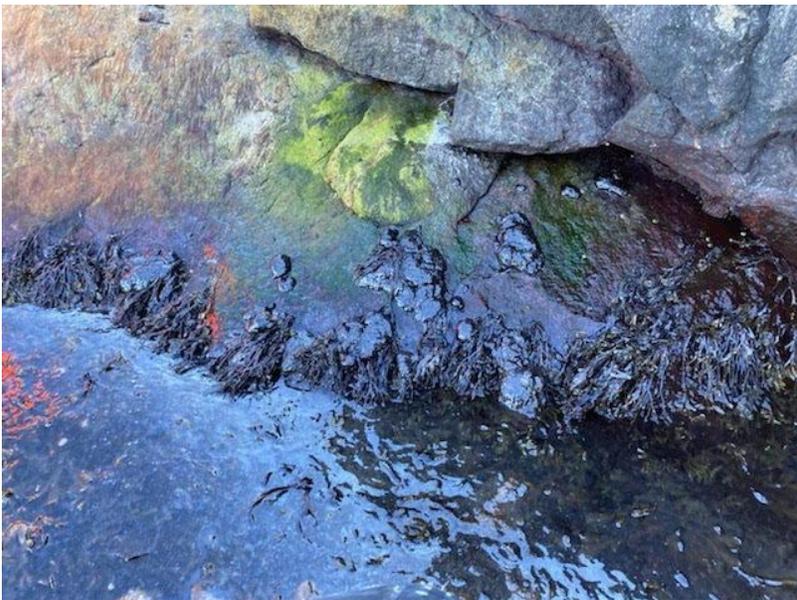
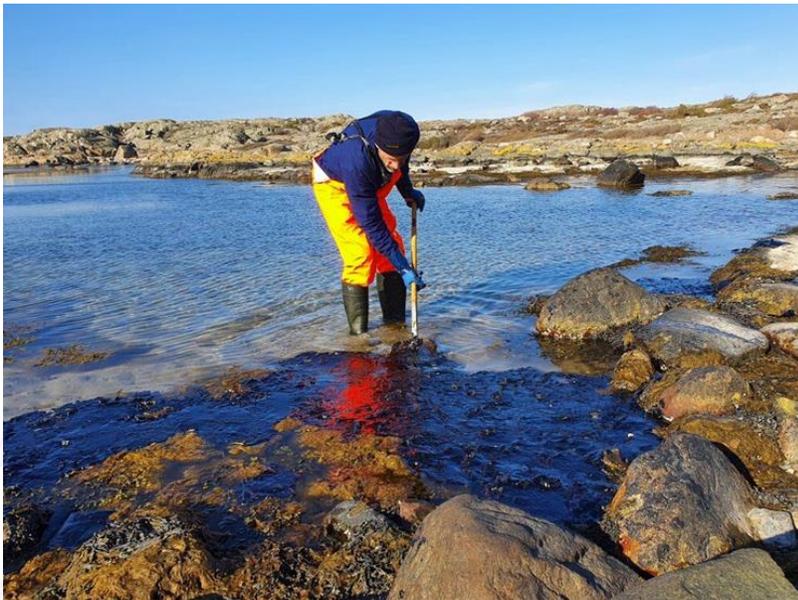
- Bad weather condition, with a fog - contributed to reduced visibility.
- Oil lumps was sinking during the night.
- Recovery operation: KBV 001, KBV 316, KBV 470. 1-1,5 m³

Oil lumps on water surface

affected municipalities started clean-up operation
