DOCUMENTATION OF EFFECTIVENESS IN OIL SPILL RESPONSE

# Experience with efficiency in mechanical recovery in oil spill response

**Report No.:** 2021-0786, Rev. 01

**Date:** 2021-11-24

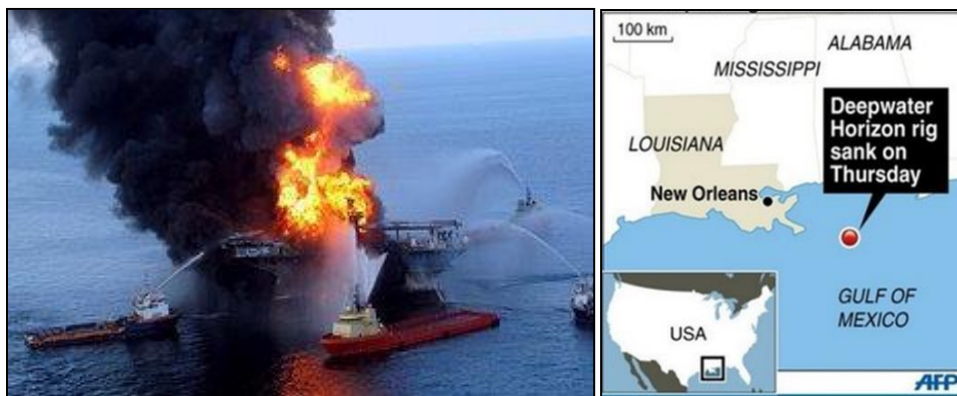
**Figure 4-1** Explosion at the Deepwater Horizon drilling rig 20. April, 2010 off the coast of Louisiana.

On 20 April 2010, some 66 km off the coast of Louisiana, the oil rig Deepwater Horizon (drilling at the Macondo/MC 252 well in the Gulf of Mexico) suffered an explosion followed by a fire. 17 people were injured, and 11 others reported missing. The US Coast Guard managed to swiftly evacuate 115 of the 126 people on the rig at the time of the disaster.

The rig sank two days later, and the 2 000 to 2 500 m<sup>3</sup> of oil on the rig either burnt off or was released into the sea. A vast mobilization of spill response equipment was rapidly organized, and surveys conducted using underwater remote-operated vehicles (ROVs) reported that 159 m<sup>3</sup> of crude oil a day was leaking from the riser located 1 500 m below the surface.

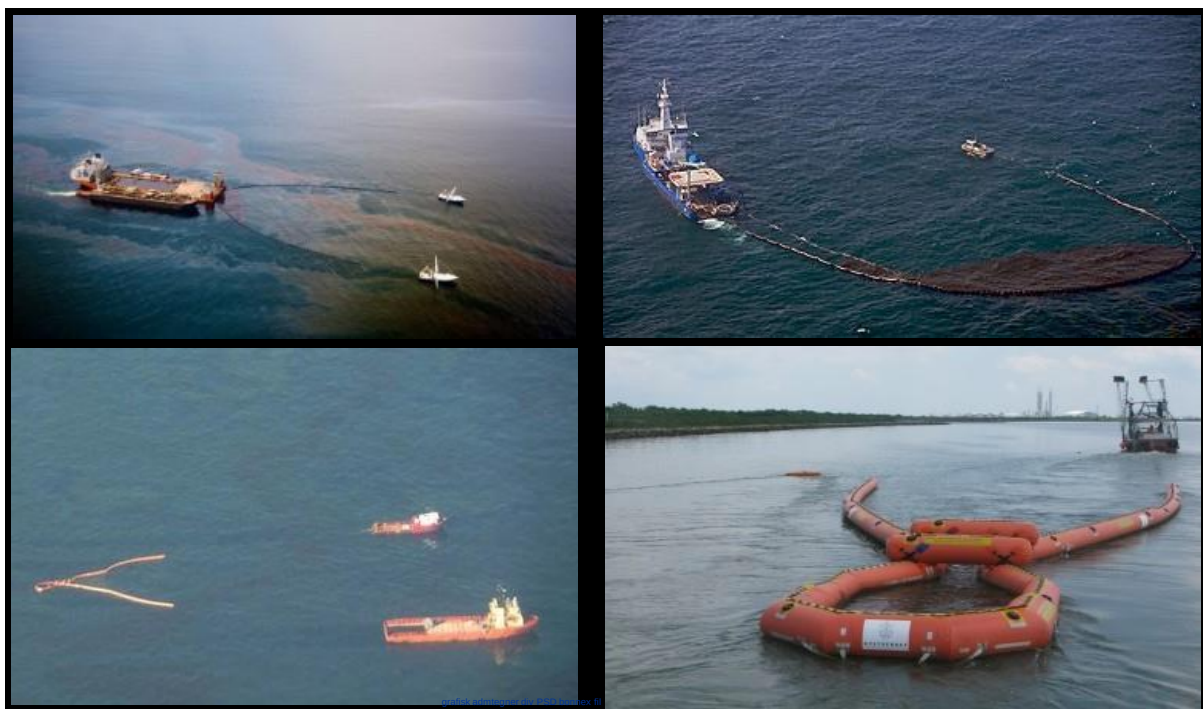
Figure 4-4 Examples of mechanical recovery systems involved in the response (offshore).

A gigantic armada response of vessels was during the first two month mobilised. By the end of July, over 6 000 ships and 540 barges had been mobilised (Figure 4-3). More than 750 different booms and skimmers systems of all types were used (see examples in Figure 4-4).

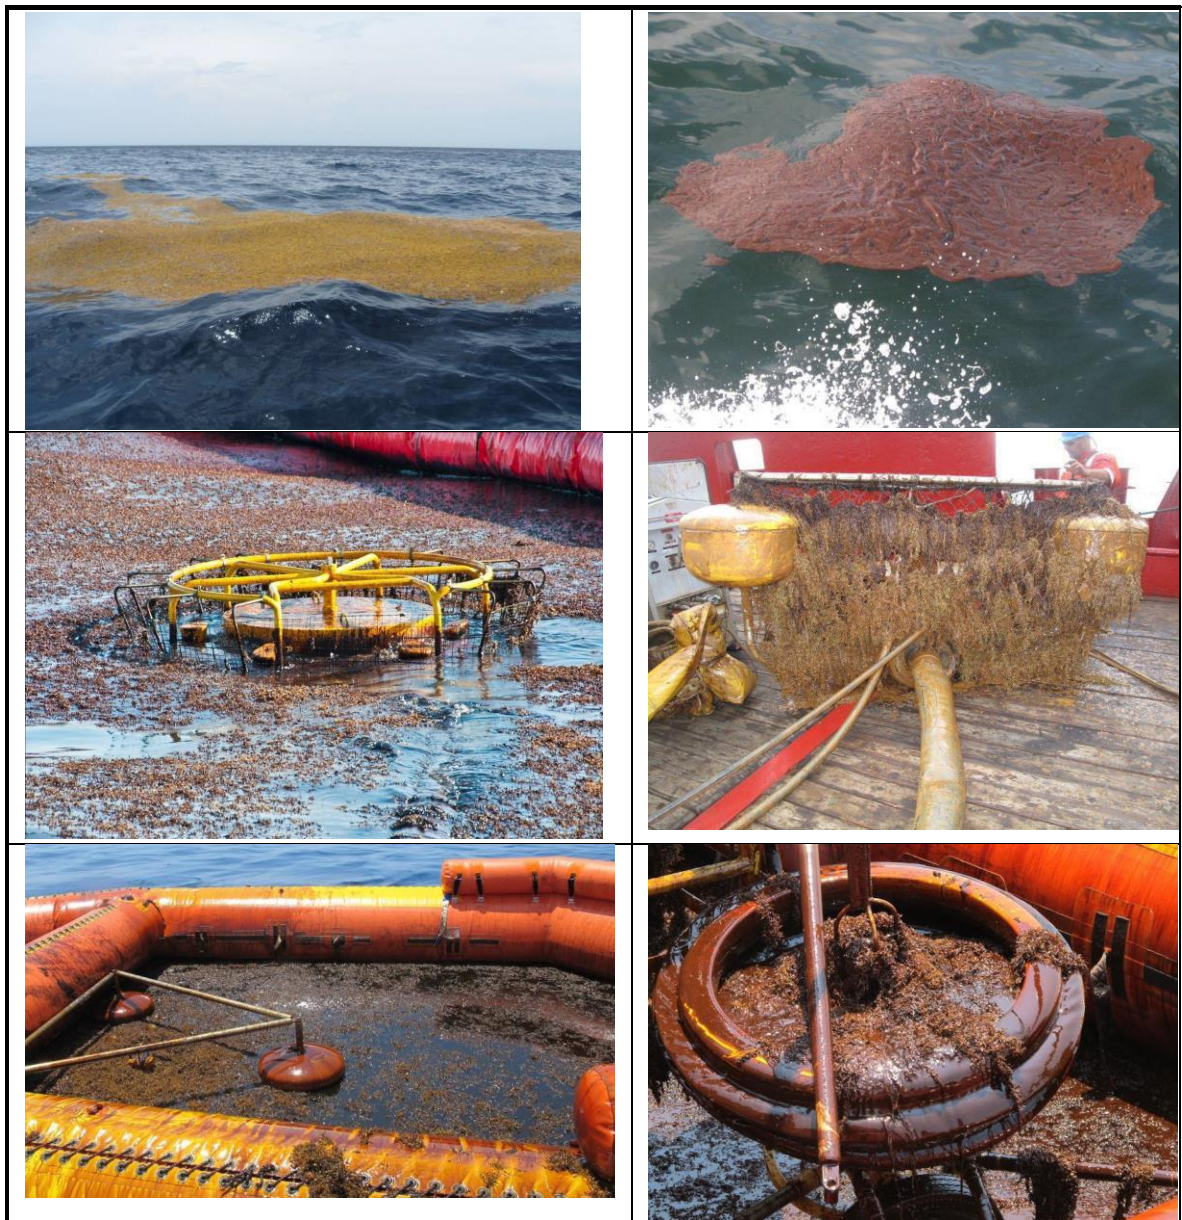
**Figure 4-6 Upper:** Patches of "seaweeds" (left) versus patches / area of emulsified oil (right) caused confused misleading guiding from spotter aircraft. Middle / down: Example of seaweed hindered the oil overflow into the Weir Skimmer systems (photos: SINTEF).

The presence of patchy areas with seaweed confused the spotter-aircraft by misleading guiding response vessels to dense areas with seaweed that could cause operational trouble for booming confinement and skimmer operations (see Figure 4-6).

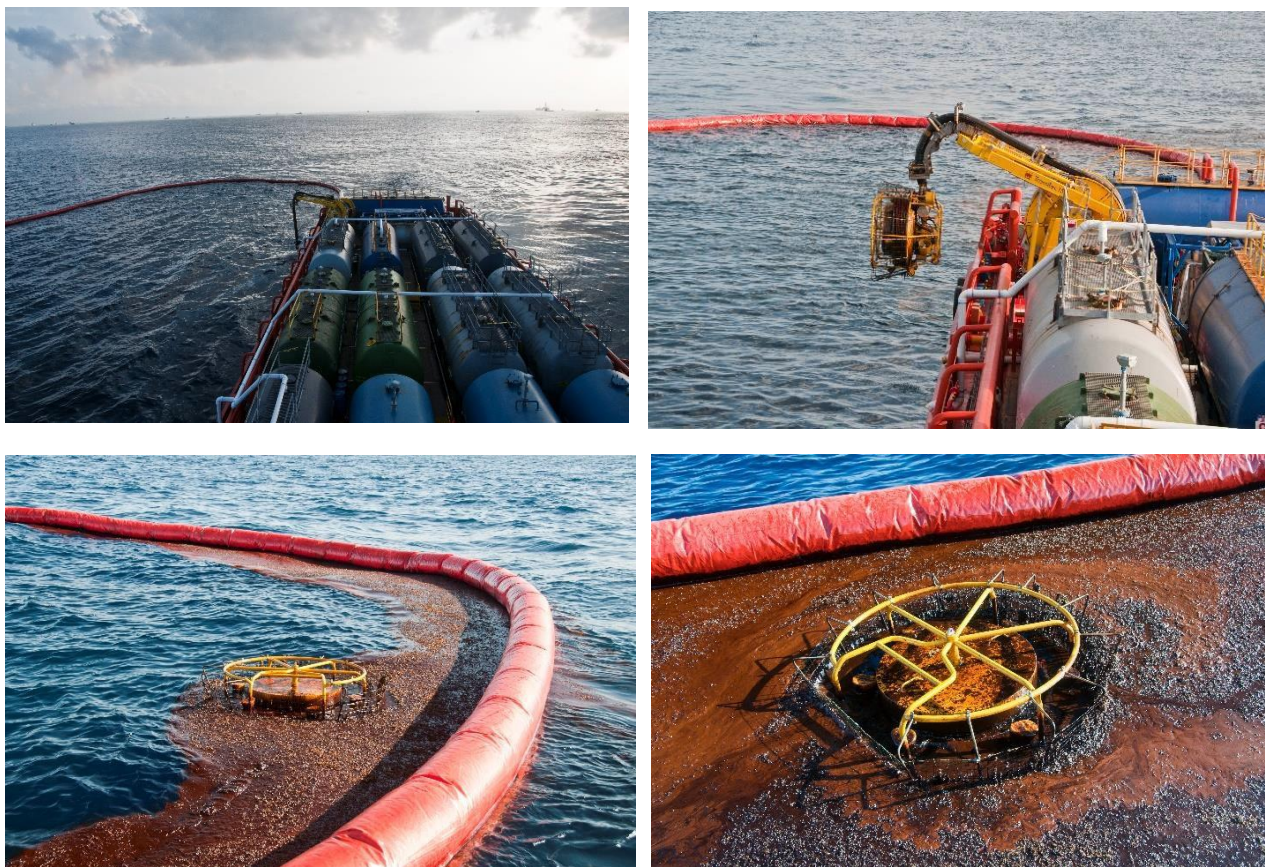
**Figure 4-11** Upper: The No-800 was operated in a "J- configuration" from Ella G. Down: "Chicken wires" mounted around the skimmer to enhance the flowability of the emulsion into the weir.

Most of the recovered emulsion was transported to port. Some of the emulsion was separated on board Ella G, however, the high content of seaweed in the recovered emulsion reduced the efficiency of the separator.

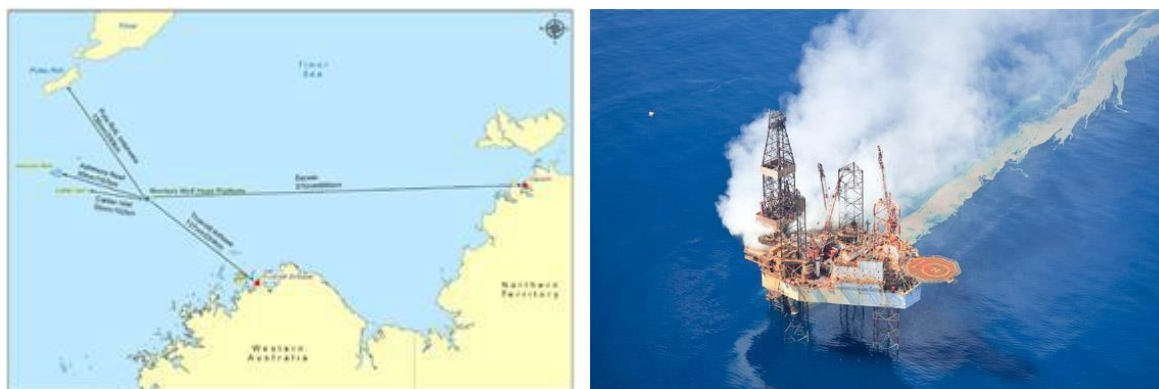
**Figure 4-12** Map showing the position of the Montara platform (left) and a picture showing the oil rig and the oil slick floating away (right). The picture taken by Mark Hamilton and both images copied from:

The 21. August 2009, an uncontrolled discharge of oil and gas occurred from the Montara Wellhead mobile drilling unit. The incident occurred approximately 230 km off the north-west coast of Australia in the Montara offshore oil field in the Timor Sea (Figure 4-12). The 69 engineers and technicians on the rig were immediately evacuated unharmed to Darwin.

PTTEP Australasia, the platform operator, estimated that 64 tonnes (400 barrels) of crude oil was being lost per day. It should be noted, however, that this estimate could not be confirmed at any time during the incident, nor was it possible to provide any more accurate assessment. The leak continued until 3. November 2009. An estimated total of 4 800 tonnes was then released into the sea. Response operations continued until the well was capped on 3. December 2009 (105 days). The slick created stretched up to 40 km wide by 136 km long.

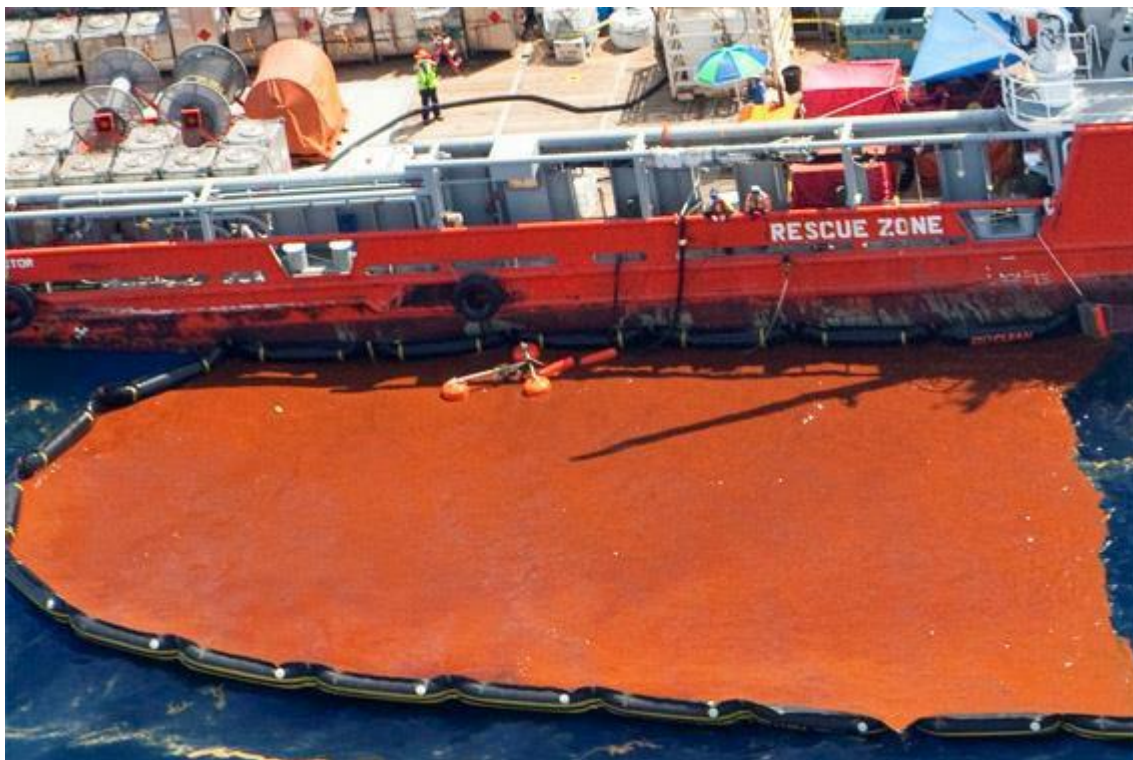
**Figure 4-13** Rust-colored emulsion confined in a boom ready for recovery by the skimming system. Photo: AMSA.

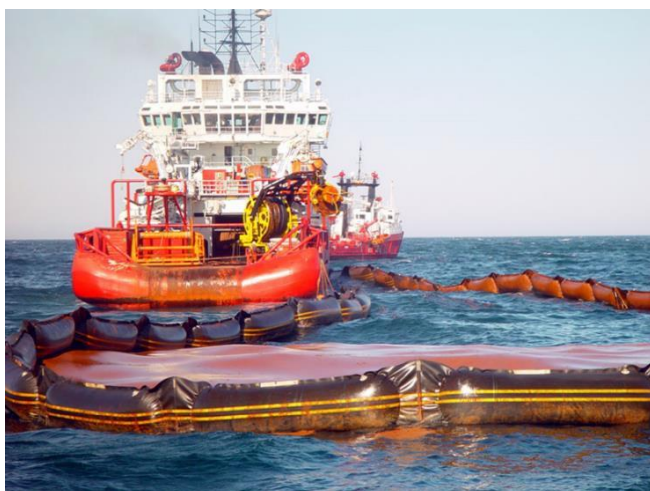
**Figure 4-19** Emulsion confined in a boom ready for recovery by the Transrec system onboard "Skandi Stord."

Figure 4-19 shows a picture of emulsion confined in the boom by "Skandi Stord". Experience from the recovery operations showed that the Transrec system pumped a lot of free water. The viscosity of the emulsion was measured to 4 400 – 10 000 cP (measured at a shear rate of 10 s<sup>-1</sup> and a temperature of 10 – 12 °C) after 3-4 days at sea. It was reported that a dosage of more than 1 000 ppm of emulsion breaker (Alcopol) was necessary to break the emulsion. There were problems with emptying the tanks with recovered emulsion from the OR vessel.

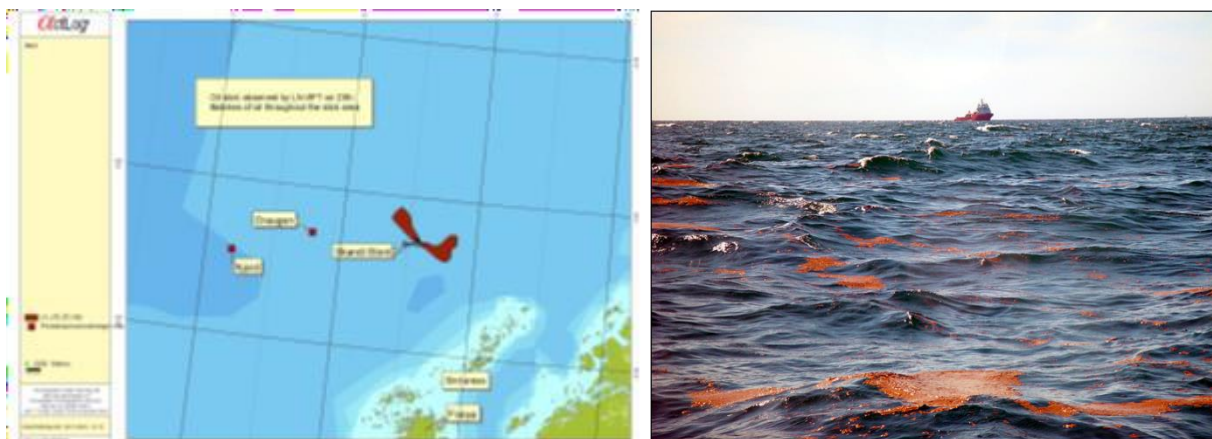
**Figure 4-20** After 3 days (May 23.) the oil had drifted towards east and was spread over large areas with patches of orange/reddish emulsion.

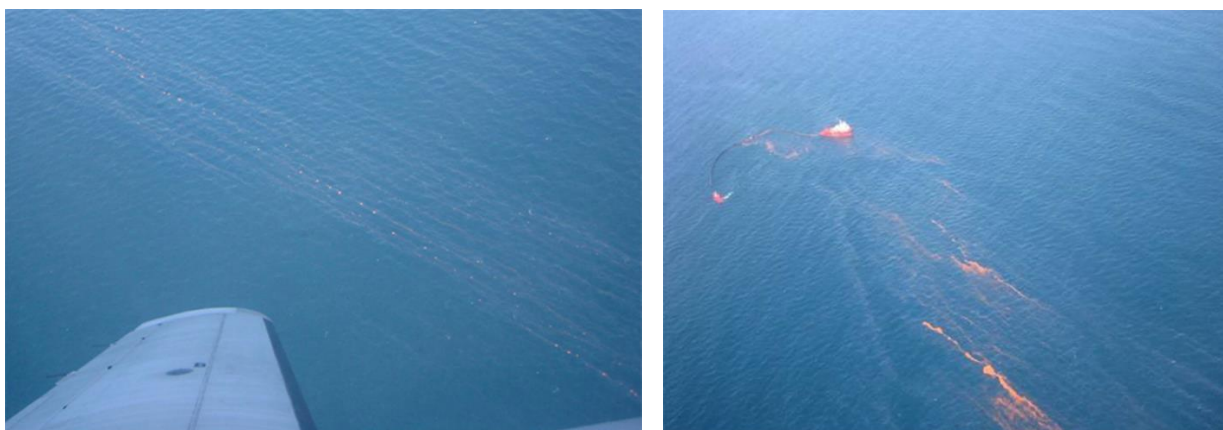
**Figure 4-21** Observations from LN-SFT 24. May 2003. The left picture show patches of emulsion 1-5 m in diameter surrounded by sheen. The right picture shows an area with larger patches, 50 -100 m long).

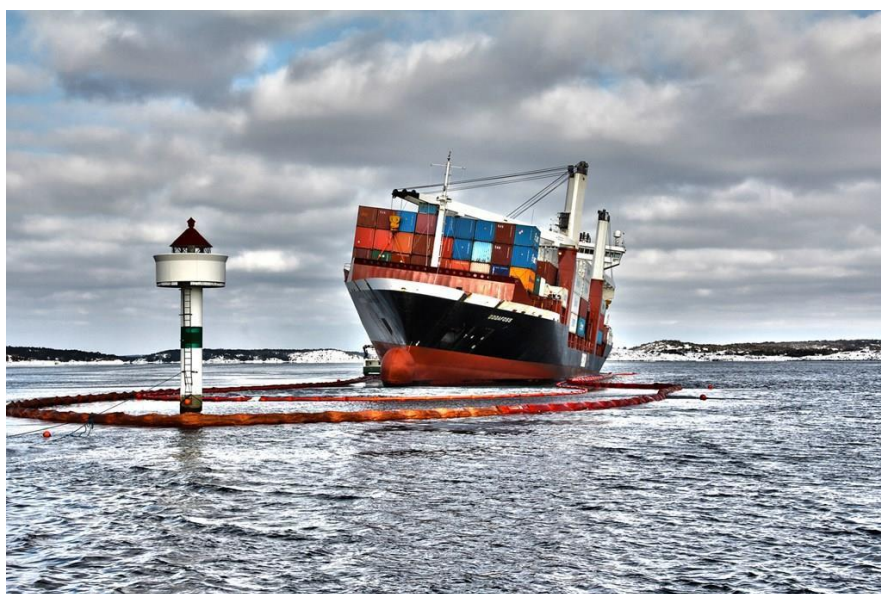
**Figure 4-24** Godafoss after the grounding. Photo: NCA.

The 17<sup>th</sup> of February 2011, the container vessel Godafoss was on its way out of the town of Fredrikstad when it grounded on the Kvernskjær-reef in the Hvaler archipelago (Figure 4-24 and Figure 4-25). The vessel was loaded with 439 containers and had 555,5 m<sup>3</sup> heavy fuel oil (IFO 380) on board.

At 20:00, Horten VTS received a report of the grounding. The vessel suffered extensive damage to the underside of the hull, and four oil tanks were damaged/penetrated. 112 cubic metres of heavy oil quickly flowed into the sea. Efforts were made extensively at sea and along land to limit the harmful effects of the discharge. In parallel of the on sea-response, remaining oil in the ruptured tanks were pumped out. The on-sea recovery ended 28.02 when Godafoss went out of Norwegian waters to Denmark for repairs.

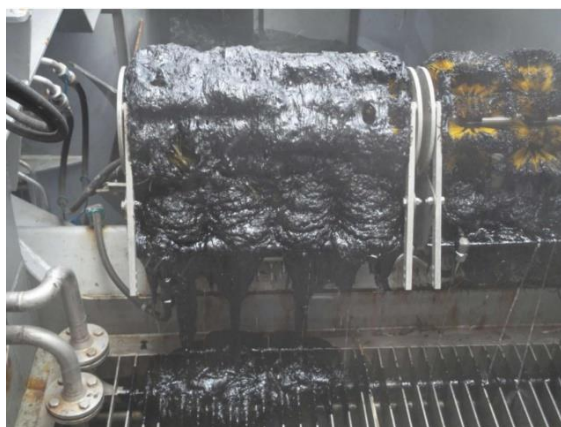
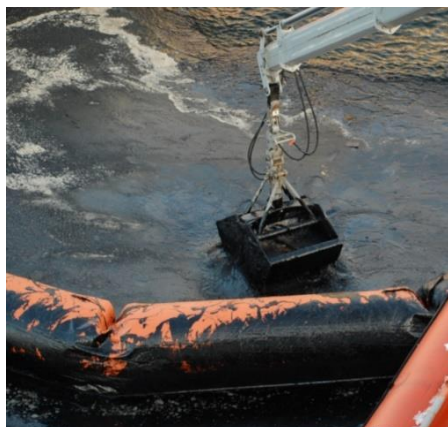
**Figure 4-26** Viscous oil due to low temperatures (Photo: NCA).

The response was carried out in very cold weather conditions. A high-pressure system over southern Scandinavia led to low temperatures as low as minus 20 °C. The Oslo fjord froze out to the Færder island. Difficult conditions with sea ice in the fjord around the vessel made it difficult to estimate the size of the spill. Due to low winds, the spreading of the oil was mainly driven by sea currents. Initially, the oil moved in narrow strips in the current into the Oslo fjord, and then towards Vestfold coast and down past Telemark and Agder counties. Oil was found on land as far south as Lindesnes. The cold made it very thick and easy to collect at sea and on land. When it got milder, the oil became more thin-flowing and harder to collect.

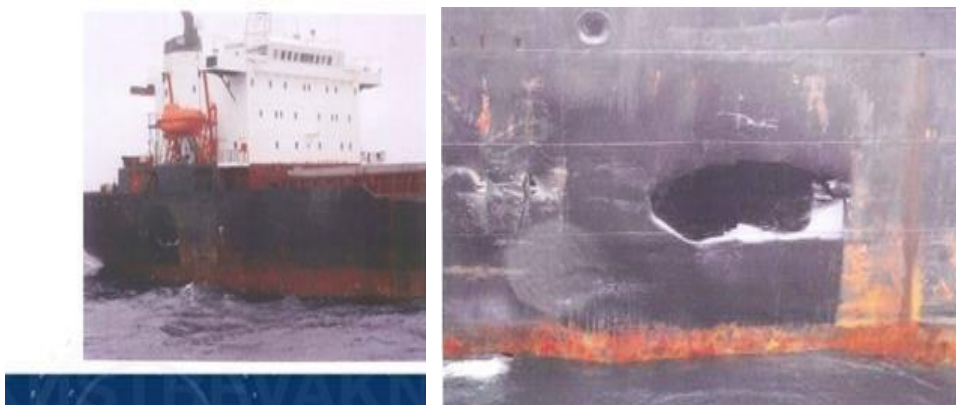
**Figure 4-29** Photos of Golden Trader after the collision with the fishing vessel Vidar (Source: Kustbevakningen, 2011).

On September 10th, 2011, bulk carrier Golden Trader (28 240 GT) collided with the fishing vessel Vidar (385 GT) 39 kilometres off the western coast of mainland Denmark releasing intermediate Fuel oil (IFO 180). The oil leak was caused by breach in the hull of heavy fuel oil storage tank no. 1 on starboard side (Figure 4-29). The first entry in deck log indicated no leakage to the environment. Following this, an estimated leak of 4 m<sup>3</sup> was reported. In the investigation report, SOK provides data indicating that the collision resulted in two oil spills where the spill drifting northward was more than 400 tonnes (released within a minute) while the southern part was 150 tonnes at the most.

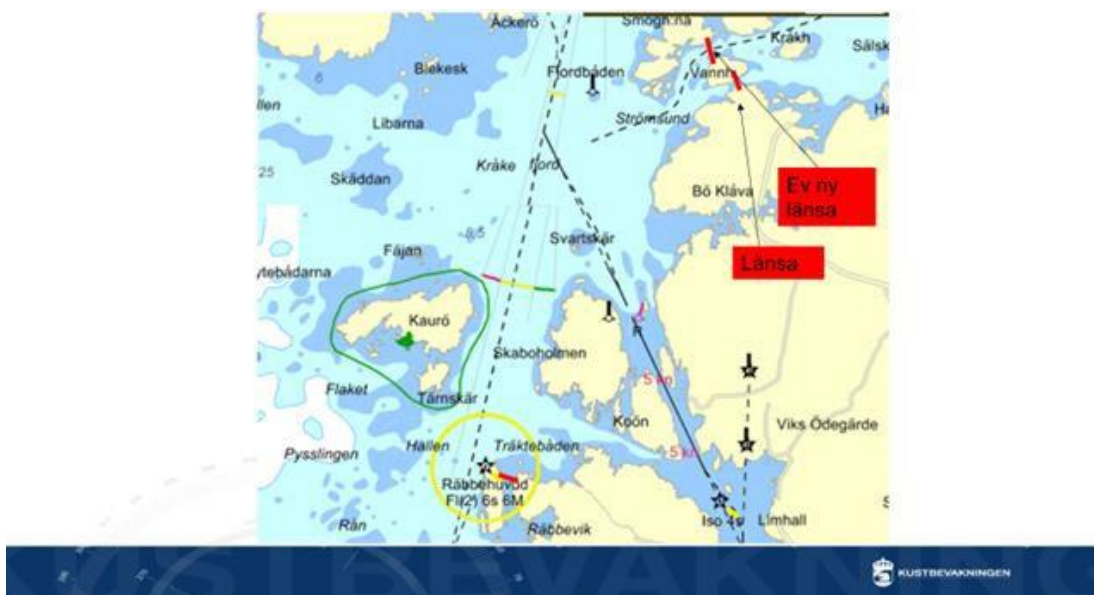
**Figure 4-30** Near shore boom location in Swedish waters on September 15th, 2011 (Source: Kustbevakningen, 2011).

The Swedish Coastguard and the Swedish Civil Contingencies Agency (MSB) pollution response team used pumps, brush skimmers and mechanical excavators to recover the emulsified oil from the water. Booms were at an early phase 15<sup>th</sup> of September placed in Strømsund Bay to limit potential oil pollution ( Figure 4-30). Swedish Army volunteers manually collected oil stranded along the coastline and conducted surveys of the many small islands impacted.

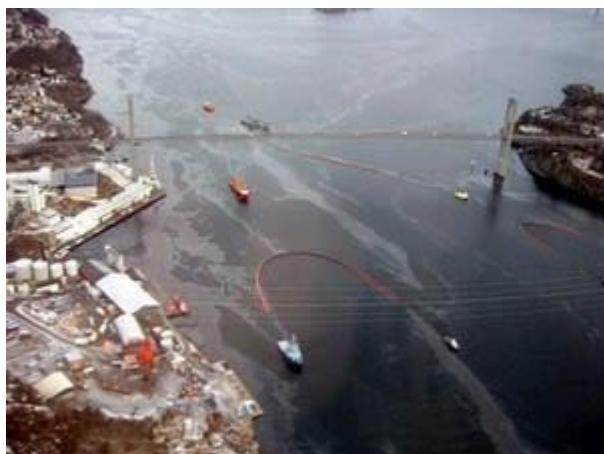
**Figure 4-37** Oil moving with tidal currents in Vatlestraumen (Photo: NCA).

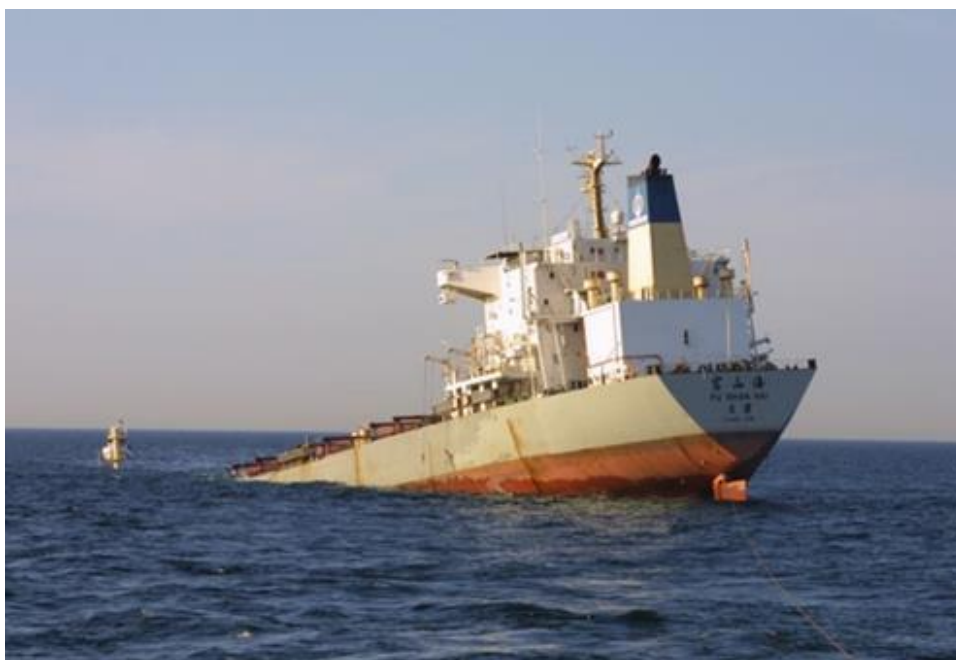
**Figure 4-42** Fu Shan Hai at time of sinking after the collision with container ship Gdynia (Source: SCG, 2003).

On May 31<sup>st</sup>, 2003, a collision between the Chinese bulk carrier Fu Shan Hai and the Cypriot container ship Gdynia occurred in the Baltic Sea, 5,6 km NNW of Hammer Odde, Bornholm, Denmark (Figure 4-41). The Chinese vessel took in water immediately and capsized. The Coast Guard vessel KBV 202 offered the Danish authorities to tow the wreck to shallower water to reduce the risk of uncontrolled oil spills. The Danish authorities declined but asked that KBV 202 stay nearby. A couple of hours later, the Coast Guard received a request from Denmark for towing. KBV 202 managed to tow Fu Shan Hai 1.5 nautical miles but was forced to cancel as it was obvious that the ship would sink shortly. Shortly afterwards, Fu Shan Hai sank to a depth of 65 meters (Figure 4-42).
