IMAROS 2

Summary report of WP4: Mechanical recovery

Deliverable D4.2

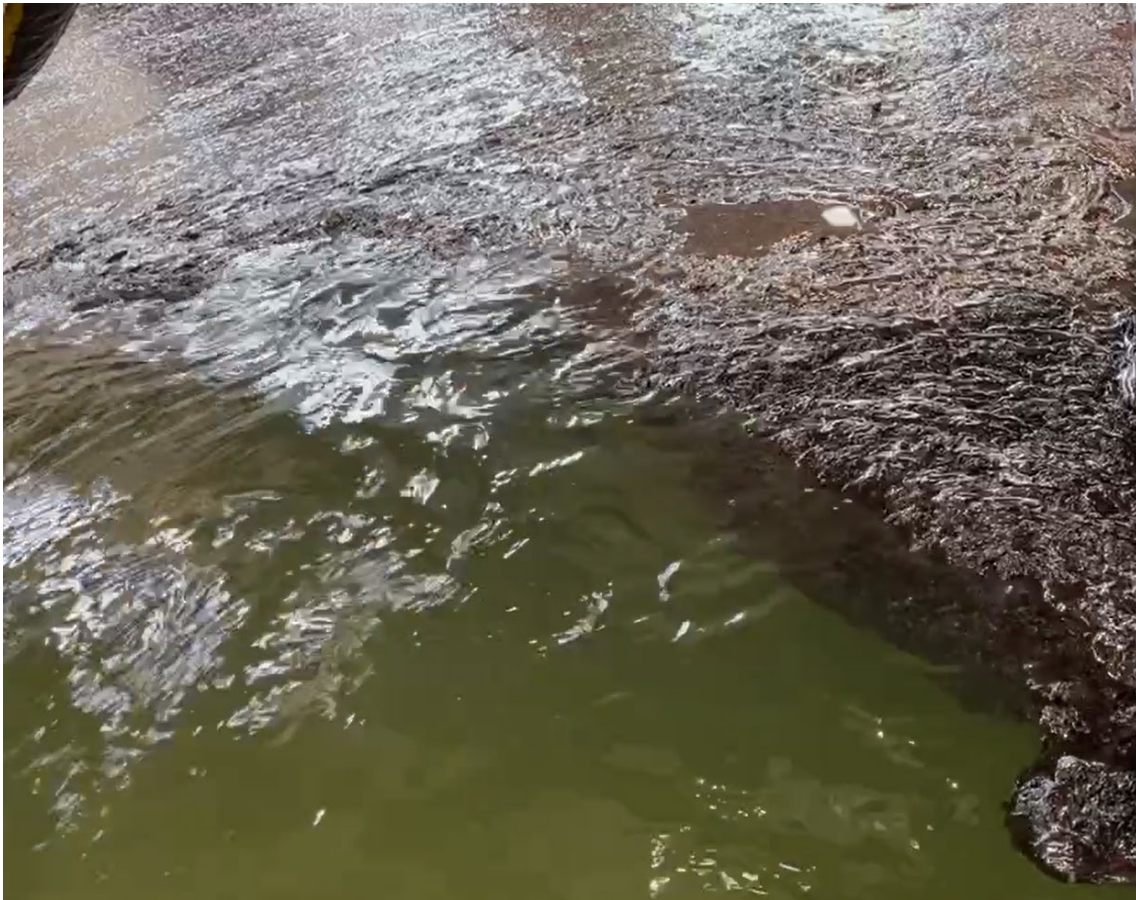
The IM-28 emulsion was dark brown with minimal colour change during the recovery tests. The emulsion exhibited high viscosity and high pour point properties and created a semi-solid slick on the water surface. The slick remained too rigid to allow for significant oil thickening at the proximity of the boom even when increasing the water current. It could be observed that the oil tended to accumulate at the far edge of the slick, with greater thickness furthest away from the boom (figure 2) and began to roll from the forces of the water current. This slick behaviour differs from prior experiences with most conventional oils, where the greatest oil thickness is closest to the boom (apex), being the natural attack point for effective recovery.

Figure 2: Photo of the edge of the IM-28 oil slick, with high thickness furthest from the boom.

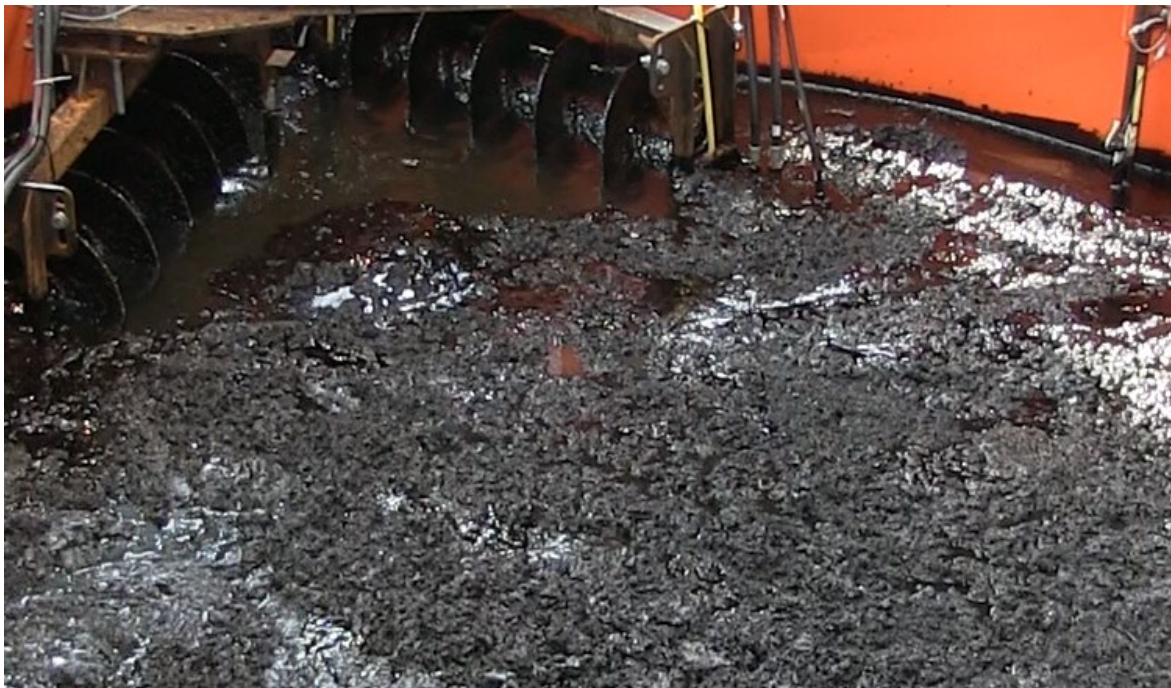
The semi-solid slick caused very poor flow properties into the skimmers and caused challenges for the skimmers during the first trial period. When operating the skimmer stationary, there was little to no flow of oil towards the skimmer, and bridging of the oil in front of the skimmer could be observed (figure 3). Oil bridging was also observed when the slick encounters an obstacle or constriction, and stayed stationary in front of the skimmer, even when increasing the water current to push the oil towards it.

Figure 3: Photo showing that the IM-28 oil is bridging in front of skimmer.

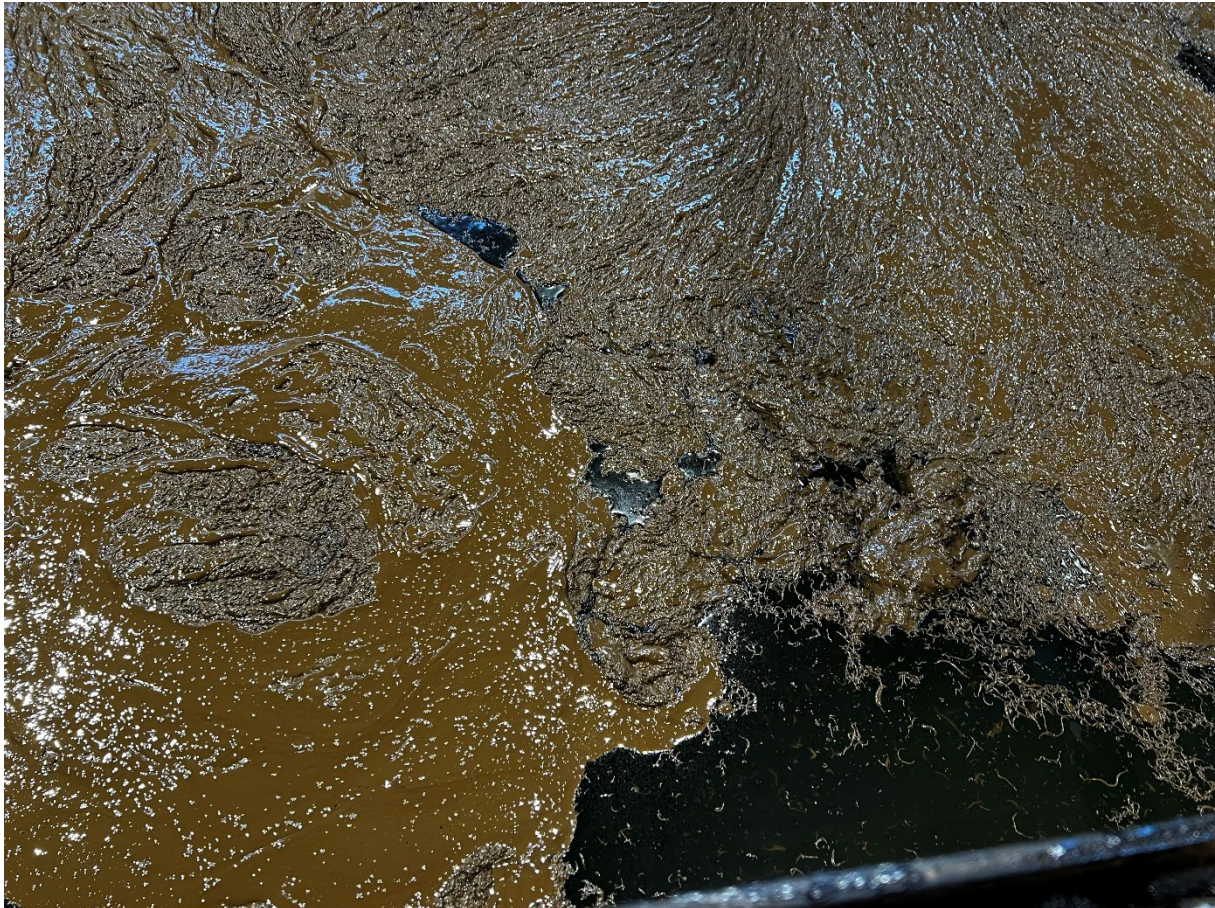
The IM-29 oil emulsion was light brown in colour and quite fluid when heated. The emulsion has a relatively low viscosity. However, upon pouring it into the basin, the oil became a semi-solid slick and at the same time it appeared to be extremely “short”, easily fragmenting in the water (figure 4).

Figure 4: Photo of fragmentation/short properties of the IM-29 oil slick.

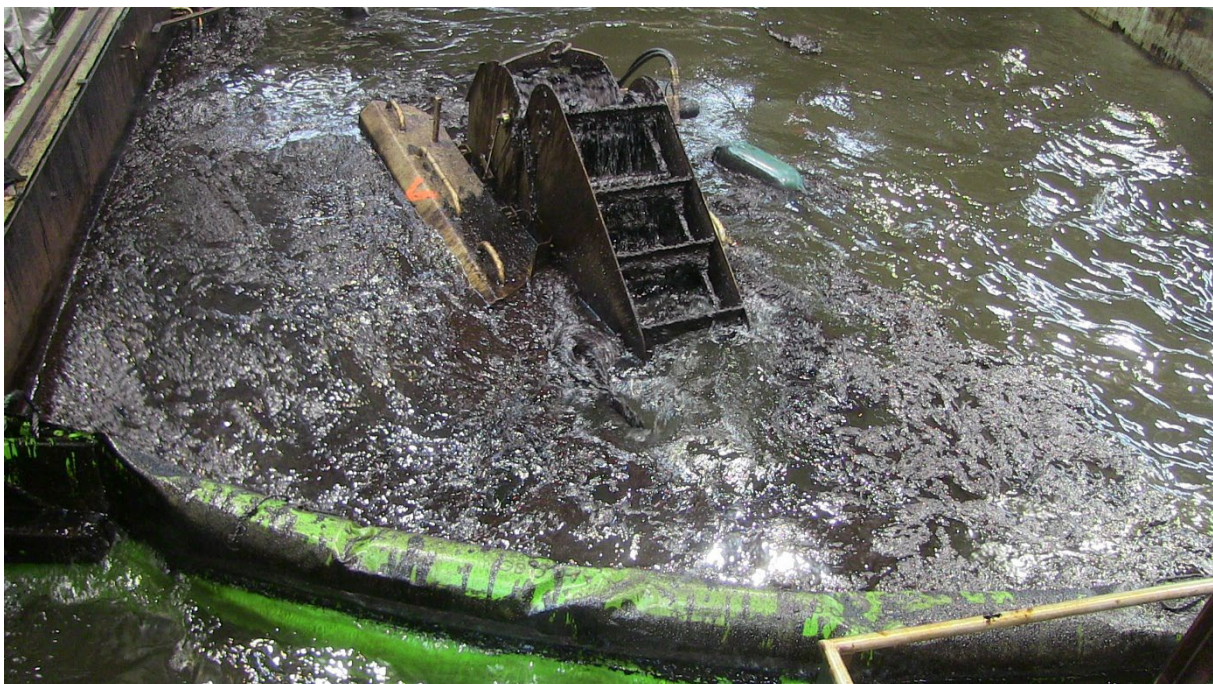
When wave action was introduced in test setup 4, the slick was more compacted than in test setup 3. This resulted in a thicker oil layer and a smaller manoeuvring area, which overall yielded higher recovery rates.

Figure 5: Photo of the Lamor LAM 50 skimmer with the feeder unit operating in the IM-28 oil.

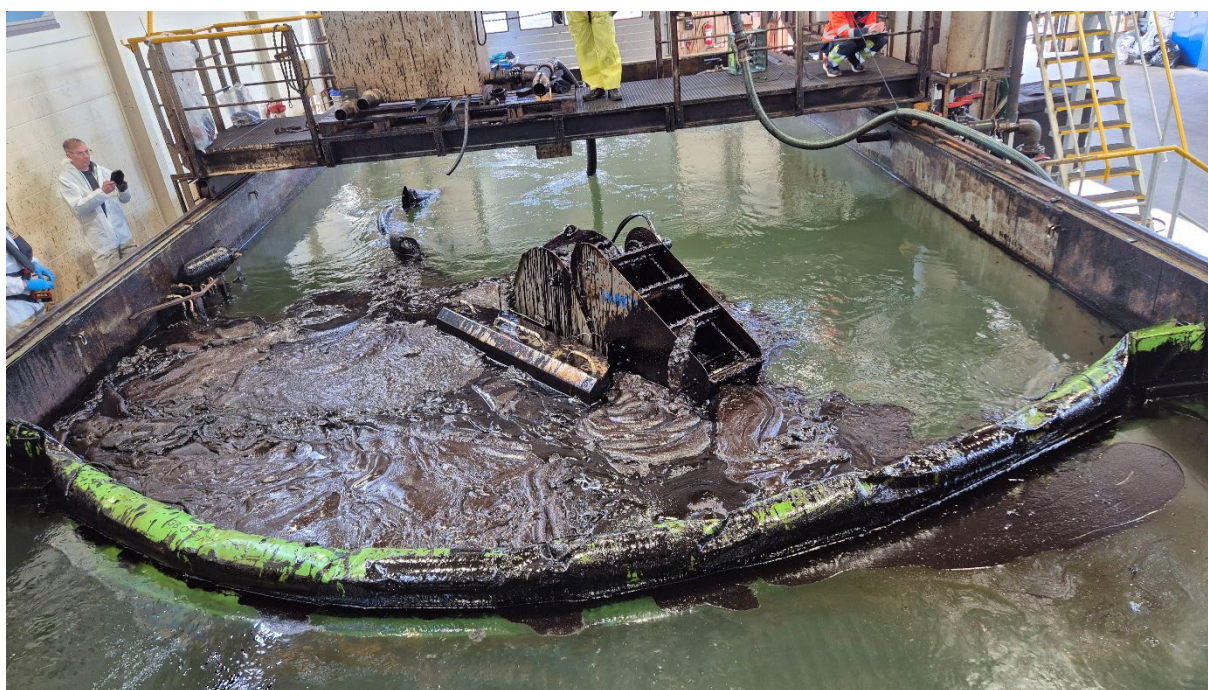
Even though the IM-29 exhibit both short and semi-solid properties, the skimmer achieved good recovery by actively using the thrusters to move in the slick in combination with the Feeder's ability to assist the LAM 50 by mechanically lift the oil all the way into the hopper. Once inside the hopper, the oil flowed into the pump and through the discharge hoses without difficulty. It appears that no heating is necessary to get this oil from the hopper down to the pump. The amount of free water collected was relatively low, although slightly higher than during recovery of IM-28. This could be related to more manoeuvring of the skimmer in the basin, as the fragmented oil slick caused the skimmer to operate occasionally in water while repositioning for more oil recovery. When operating the skimmer's pump and Feeder in combination with quite active thruster manoeuvring it can be challenging to coordinate all operations optimally. The cutting knives worked well to give the Feeder access to oil, while also creating some movement in front of the feeder brushes. When wave action was introduced in test setup 4, it gave similar recovery rates as in setup 3.

Figure 6: Photo of the Lamor LAM 50 skimmer with the feeder unit operating in the IM-29 oil.

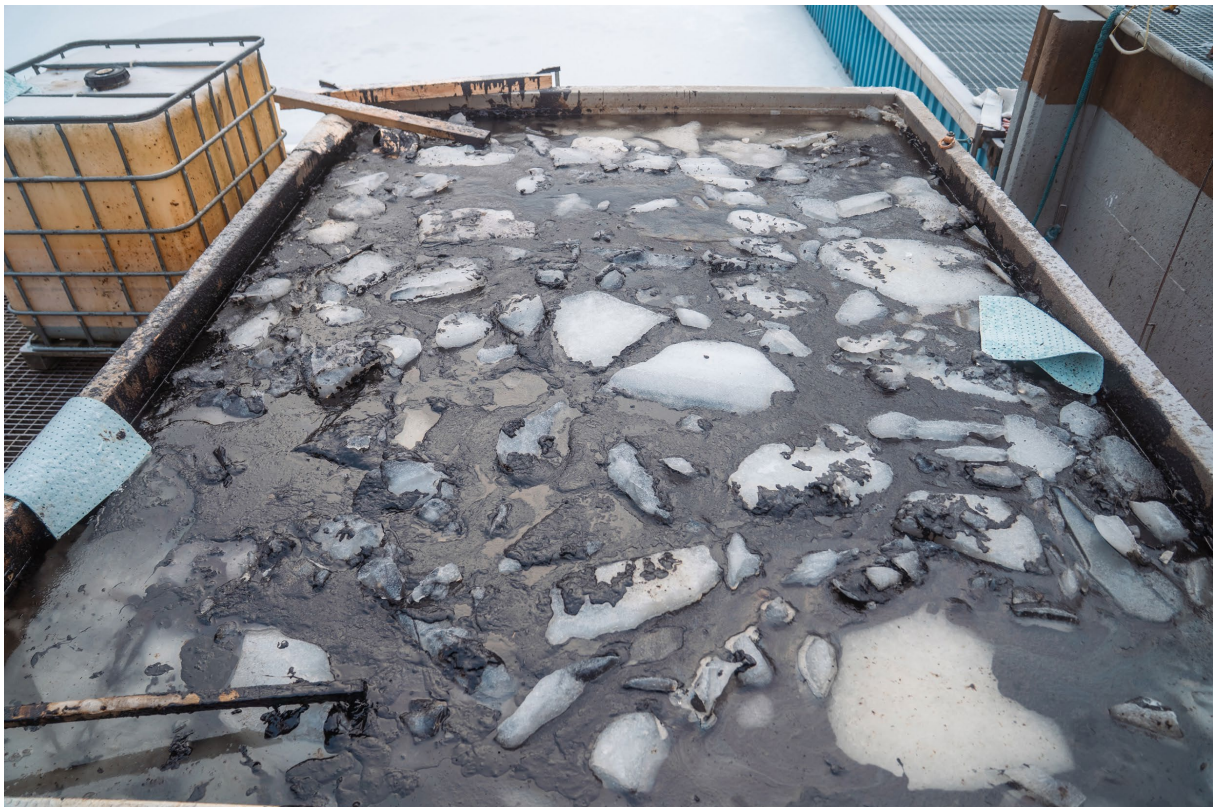
Figure 1: Picture of the test basin.

Tests were performed at South-Eastern Finland University of Applied Sciences' (XAMK) test facility in Kotka, Finland, contracted by the Finnish Border Guard. The outdoor test basin is an aluminium pool with the dimensions of 3m x 4m. The water depth of the basin was 0.8-0.9 meters. There were blocks of ice mimicking solid ice field that has a fairway broken in the sea. The ice concentration was about 80 %.

During the test days, the water temperature was ranging between 0 to 2°C and air temperature was around -2.0°C.

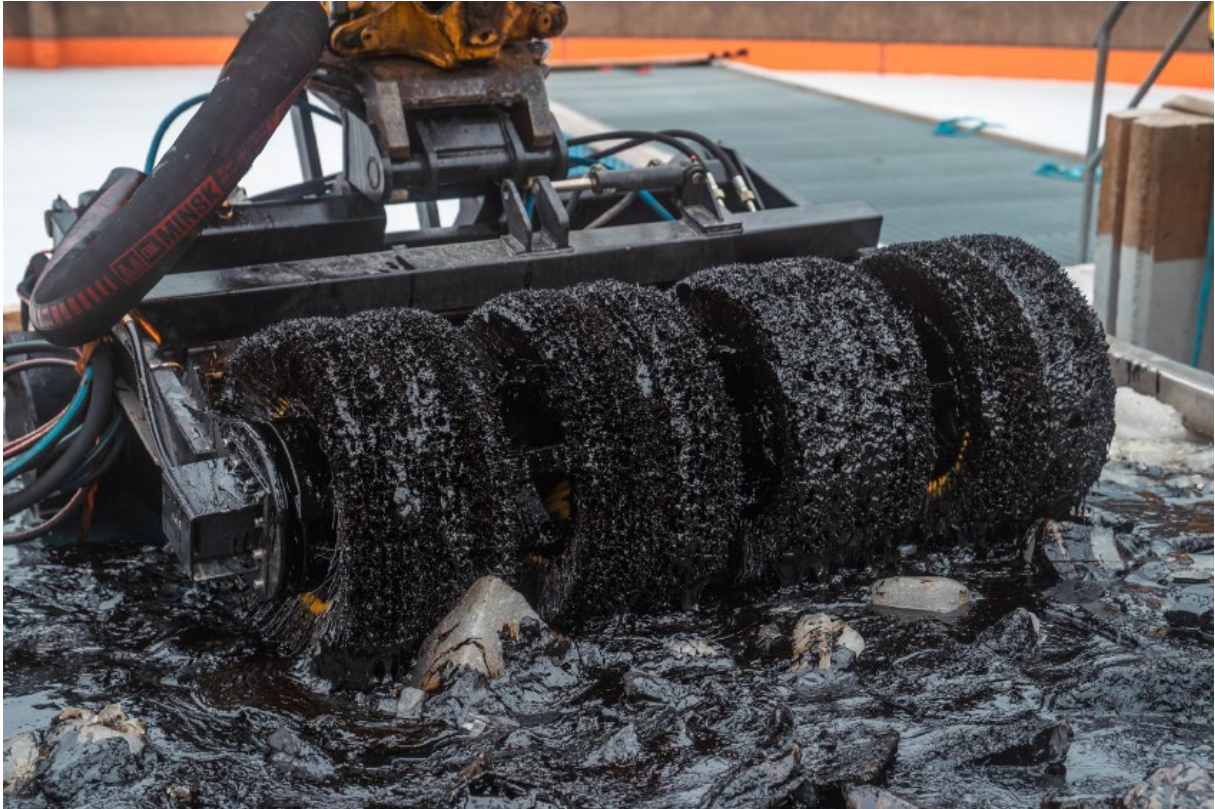
Further, the LRB is available in different sizes from 40 to 250 (indicating bucket width).

Figure 2: Picture of the skimmer.

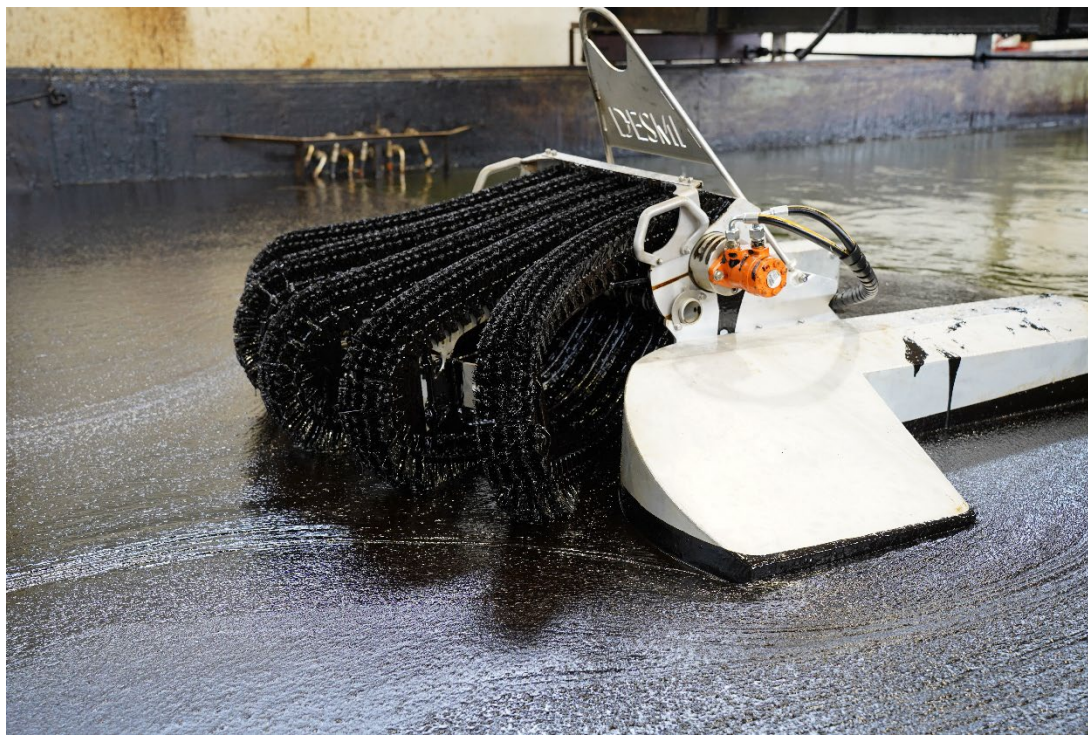
enhance oil recovery by providing a larger surface area and better access to the oil slick. These features may have had an impact in preventing the formation of a water layer between skimmer and oil. The pump and discharge hose effectively transported the oil to the collection tank without issues.

Figure 4: Photo of the DESMI modified Octopus skimmer operating in the IM-27 oil.

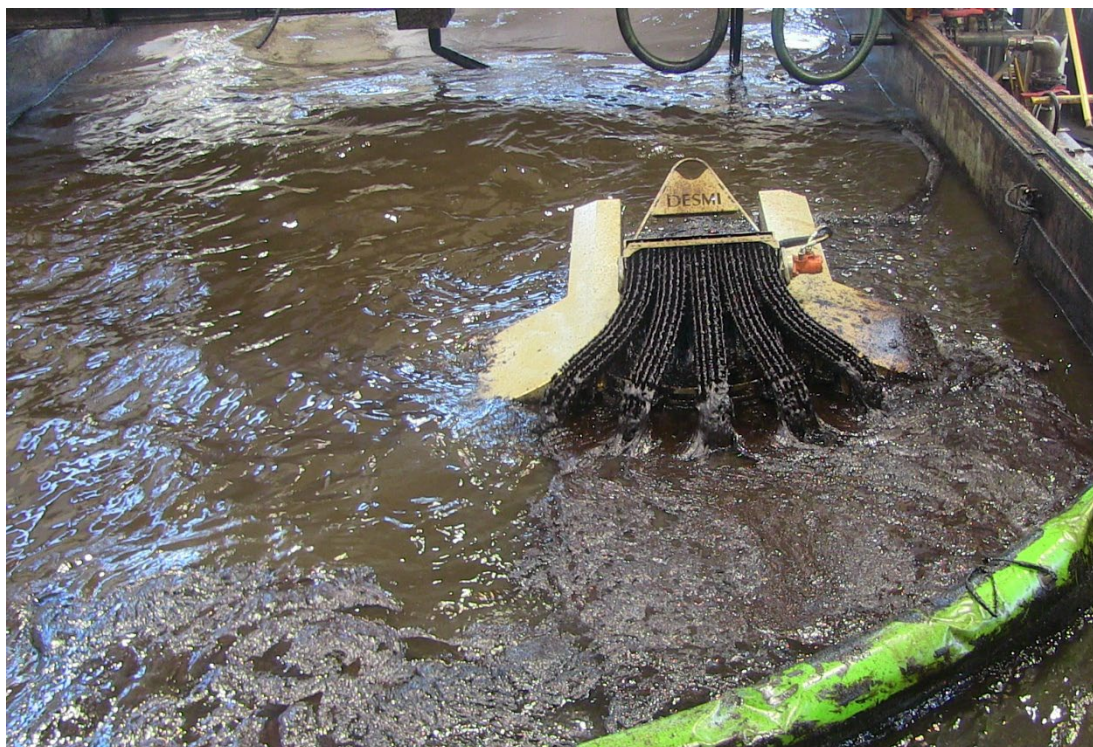
Compared to IM-27, the IM-28 recovery required more active manoeuvring in the basin, as the skimmer needed to pursue the oil and push it towards the brushes. While the thrusters provided much needed assistance for recovery, operating the skimmer in this type of oil poses higher demands on the operator in the field, who must manage the pump, brushes, and thrusters simultaneously, adding to the overall complexity of the operation.

Figure 5: Photo of the DESMI modified Octopus skimmer operating in the IM-28 oil.

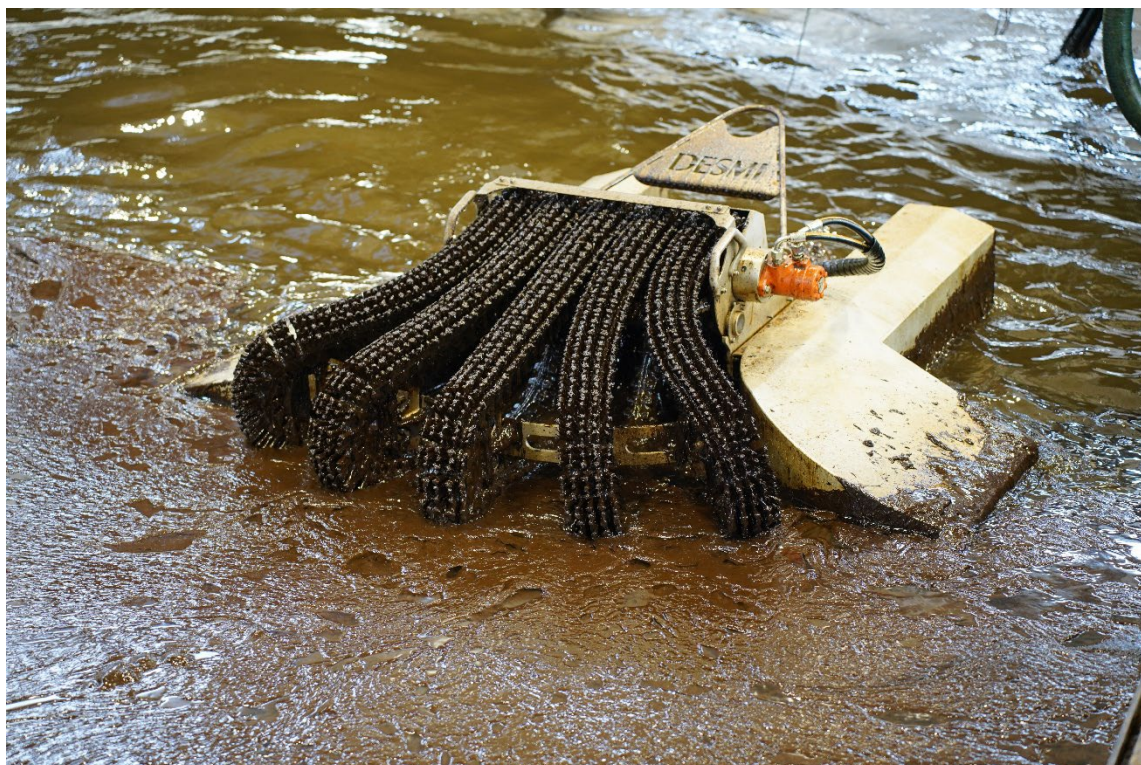
Recovery rates improved further when wave action was introduced in the basin, as the resulting fragmentation of the slick into smaller patches allowed the brushes to capture oil more effectively as it detached from the main slick. Once inside the hopper, the oil flowed into the pump and through the discharge hoses without difficulty. However, it was observed that due to the spacing between the brush arms, some oil remained trapped in the gaps and was not collected into the hopper.

Figure 6: Photo of the DESMI modified Octopus skimmer operating in the IM-29 oil.

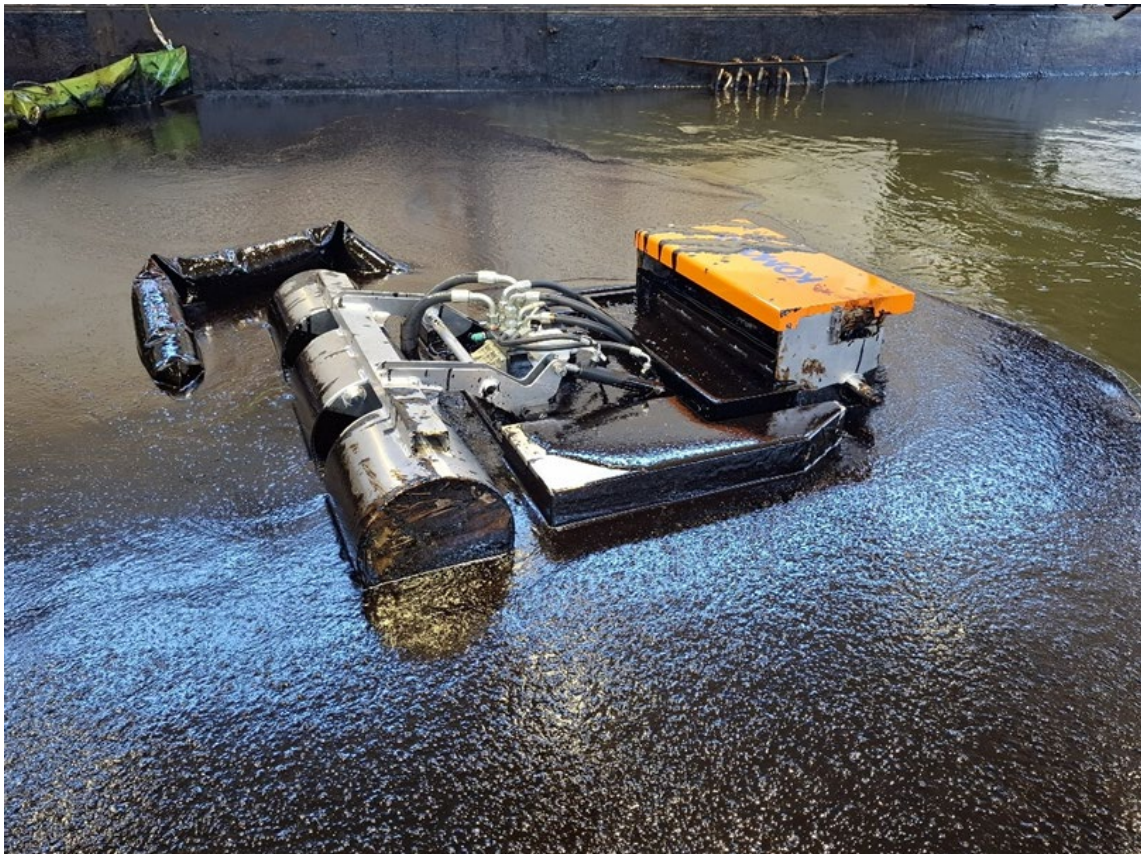
Vikoma have informed us that Komara Omni will be offered with a wider range of recovery modules including star disc and plain oleophilic discs to provide greater flexibility in recovering different types of oil.

Figure 3: Photo of the Vikoma Komara Omni skimmer (from Vikoma).

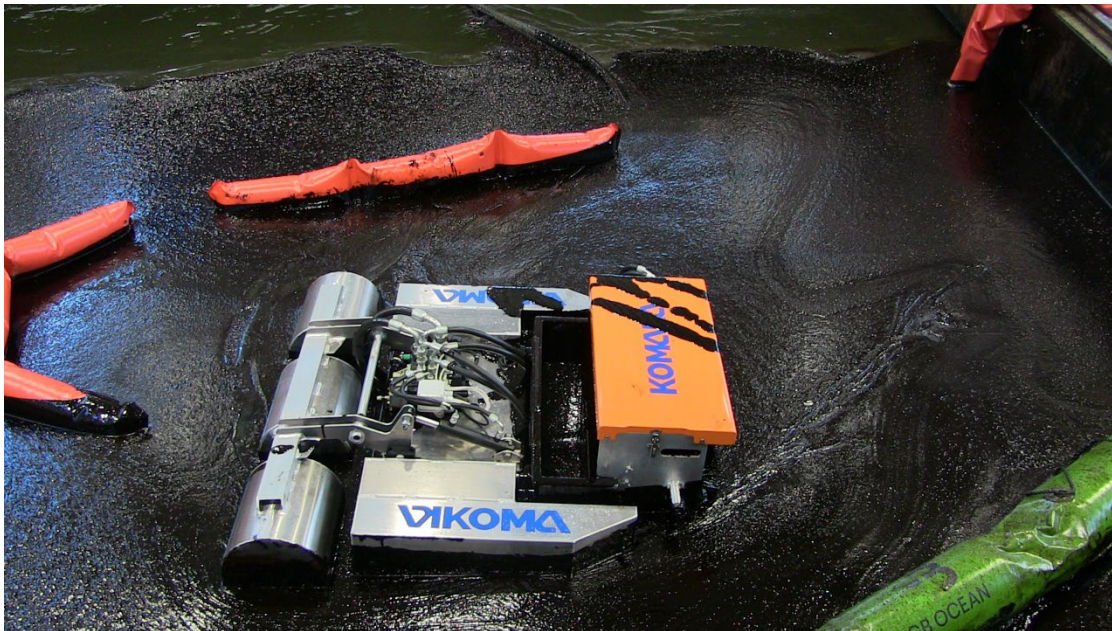
When wave action was introduced, recovery rates improved further. The skimmer remained stable in the water under these conditions, and free water uptake was further reduced, likely due to wave motion, which helped water to escape when the brush was working on the oil.

Figure 4: Photo of the Vikoma Komara Omni skimmer operating in the IM-27 oil.

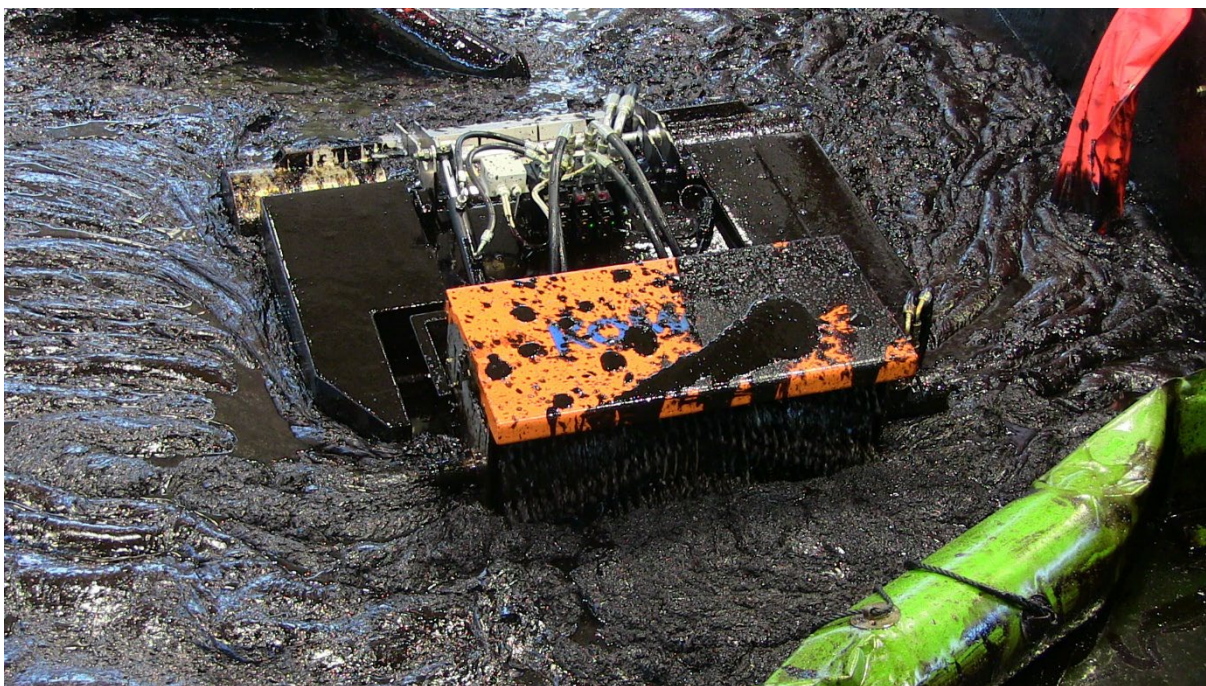
When wave action was introduced in test setup 4, the slick was more compacted than in test setup 3. This resulted in a thicker oil layer and a smaller manoeuvring area, which overall yielded slightly higher recovery rates.

Figure 5: Photo of the Vikoma Komara Omni skimmer operating in the IM-28 oil.

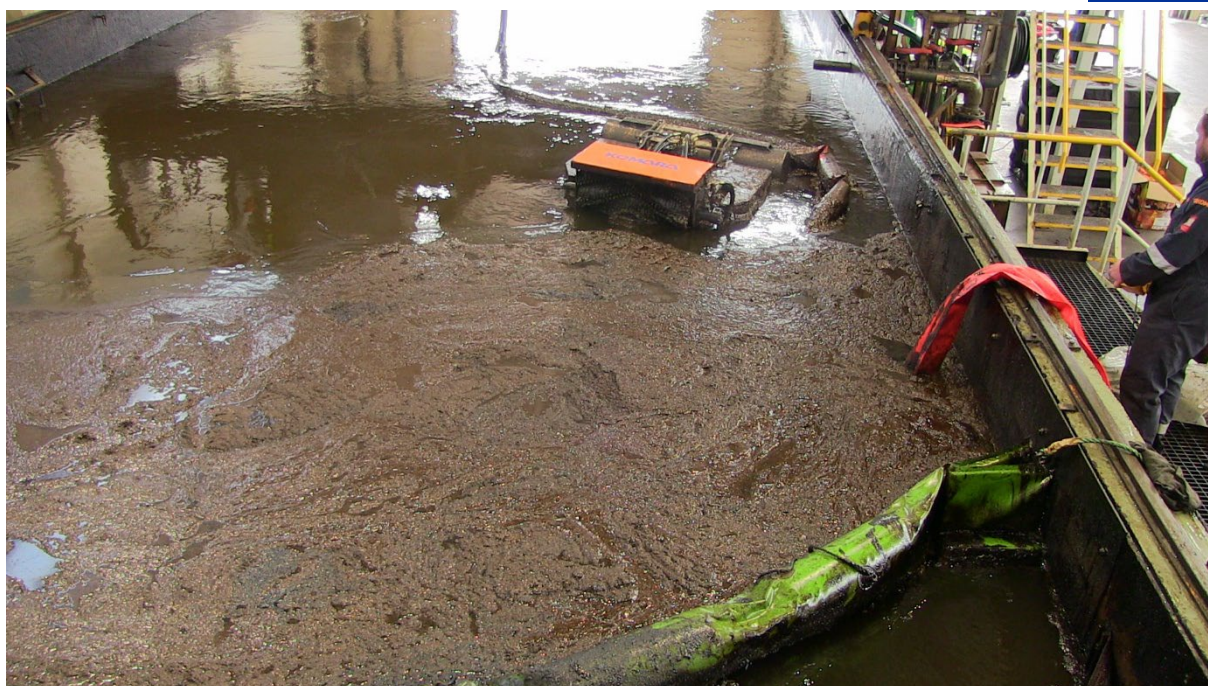
Figure 6: Photo of the Vikoma Komara Omni skimmer operating in the IM-29 oil.

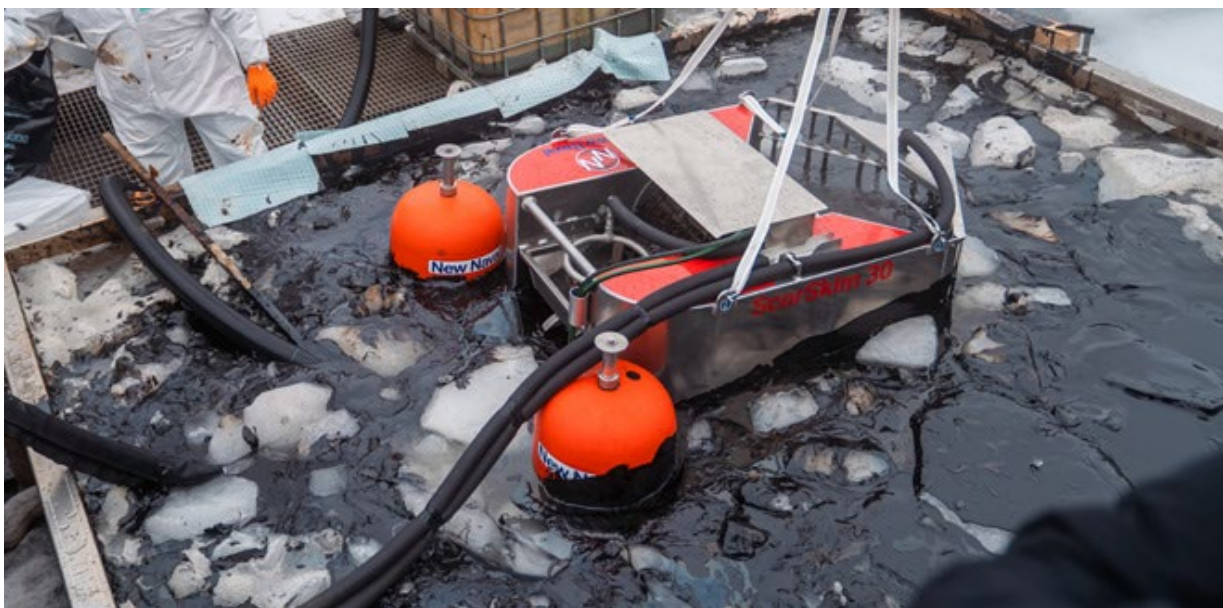
Figure 2: Picture of the skimmer.

The ScorSkim 30 is an oleophilic, free-floating skimmer designed for efficient oil spill recovery in a wide range of environments and scenarios. Its modular design allows for quick interchange between brush, disc, or drum recovery banks, depending on the viscosity and the type of target oil. Utilizing proven oleophilic technology, the system achieves oil recovery efficiency of up to 99%. Compact and easy to deploy, the ScorSkim 30 is well-suited for nearshore, harbour, and offshore operations.

It features an integrated on-board pump capable of recovery rates up to 54 m³/h. The skimmer is hydraulically driven, with low power requirements and quick couplings for seamless connection to a dedicated power pack. Constructed with durable, marine-grade aluminium, the system is highly resistant to oil, dispersants, and seawater. Two external floats provide enhanced stability and buoyancy. For operations in icy conditions, the skimmer is equipped with a front-facing ice-breaking grid and two steam injection circuits: one at the front and one at the pump's suction inlet to ensure continued performance in cold environments.

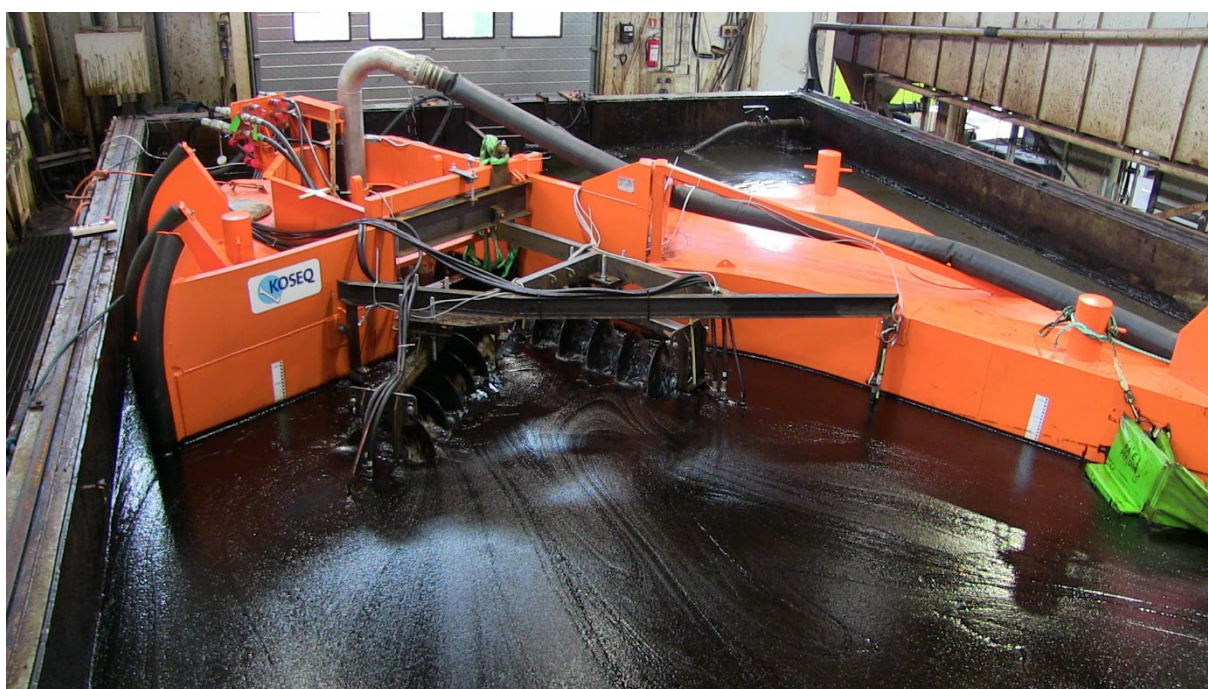
Figure 4: Photo of the Koseq modified Sweeping Arm weir skimmer operating in IM-27.

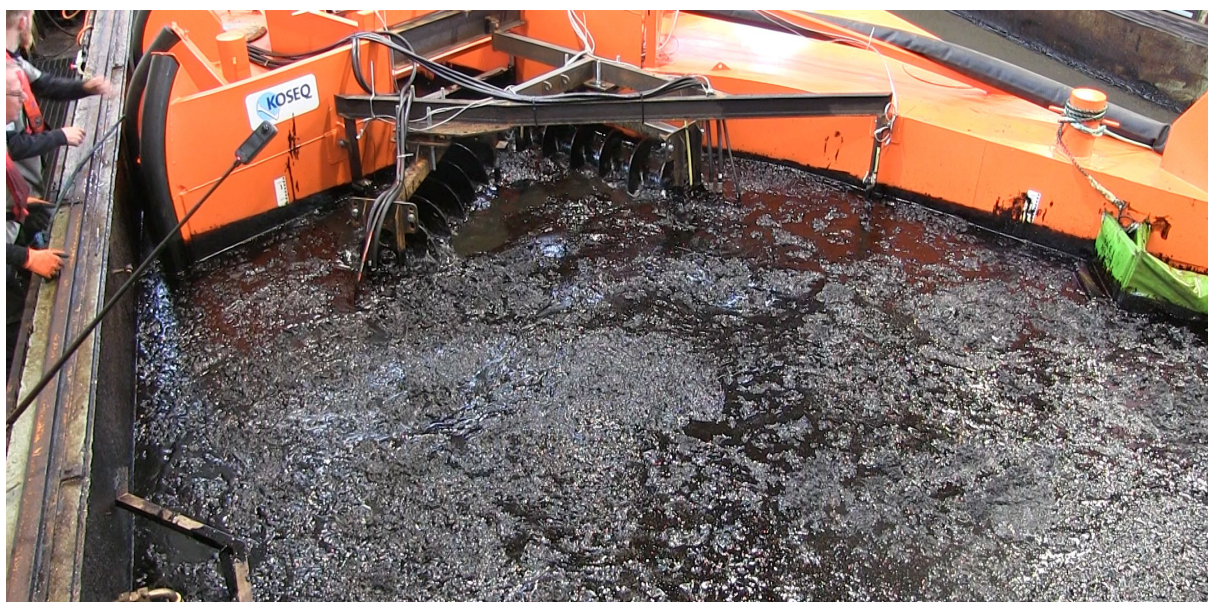
Figure 5: Photo of the Koseq modified Sweeping Arm weir skimmer operating in IM-28.

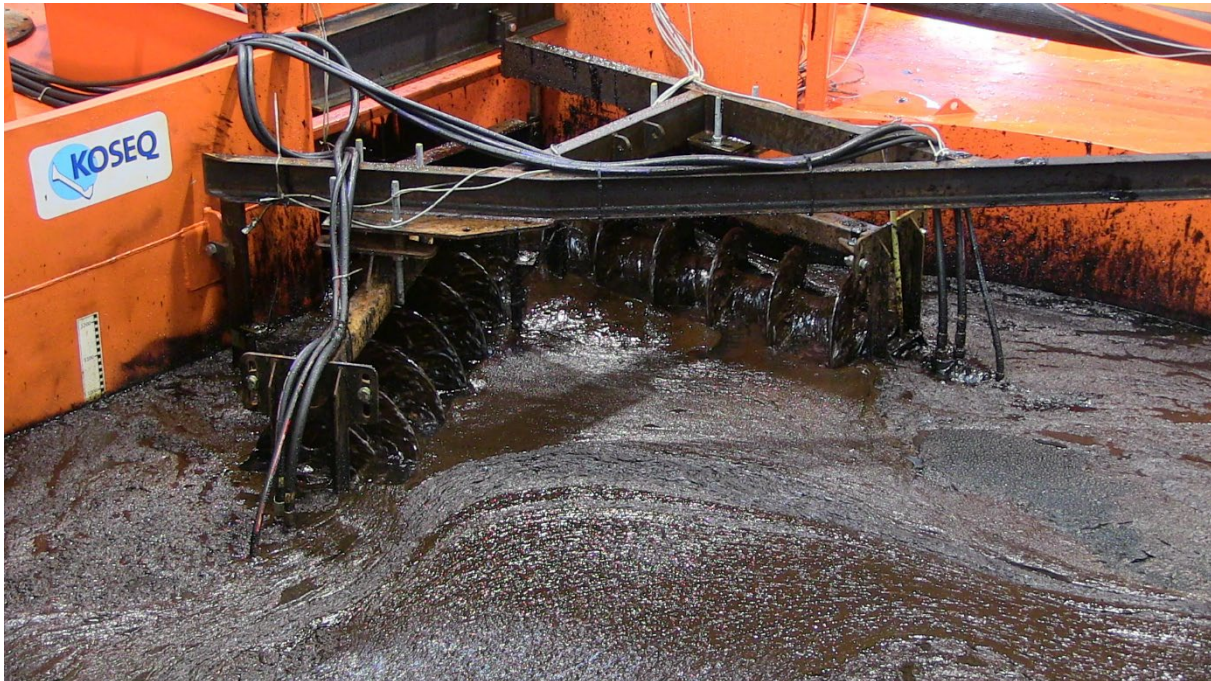
Figure 6: Photo of the Koseq modified Sweeping Arm weir skimmer operating in IM-29.
