Makassar Highway

23 July – 3 August 2018

- On July 23 2018 Panama-flagged Makassar Highway ran hard aground in the Baltic Sea near Västervik, Sweden.
- 139m long, 23m wide ,1325 vehicles
- 333m³ bunker oil, 38m³ diesel and 25m³ lubricating oil

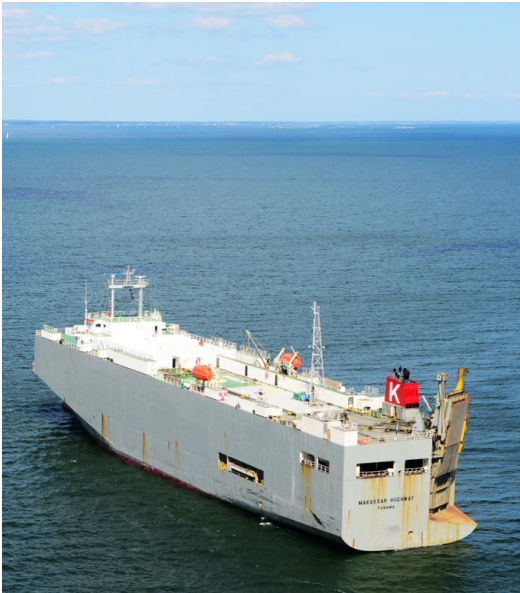
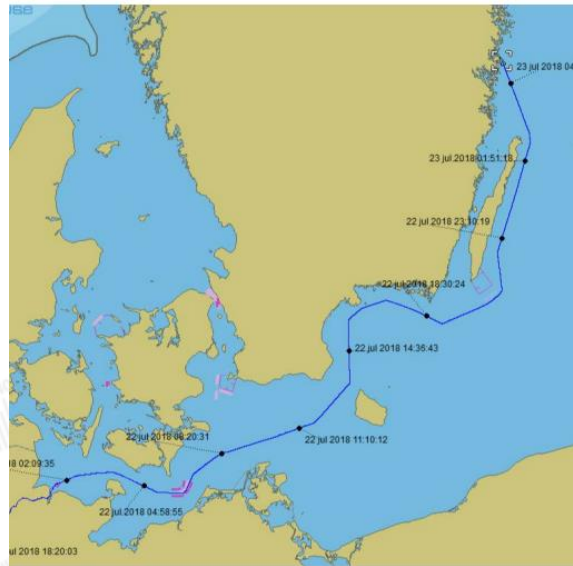
- Makassar's satellite system was not working and Officer in command wanted to get closer to land.

- The vessel deviated from the normal route in fairway.

The dashed **blue line** shows the route that ships of this type normally travel.

The **yellow line** shows Makassar Highway's journey along Öland's east side.

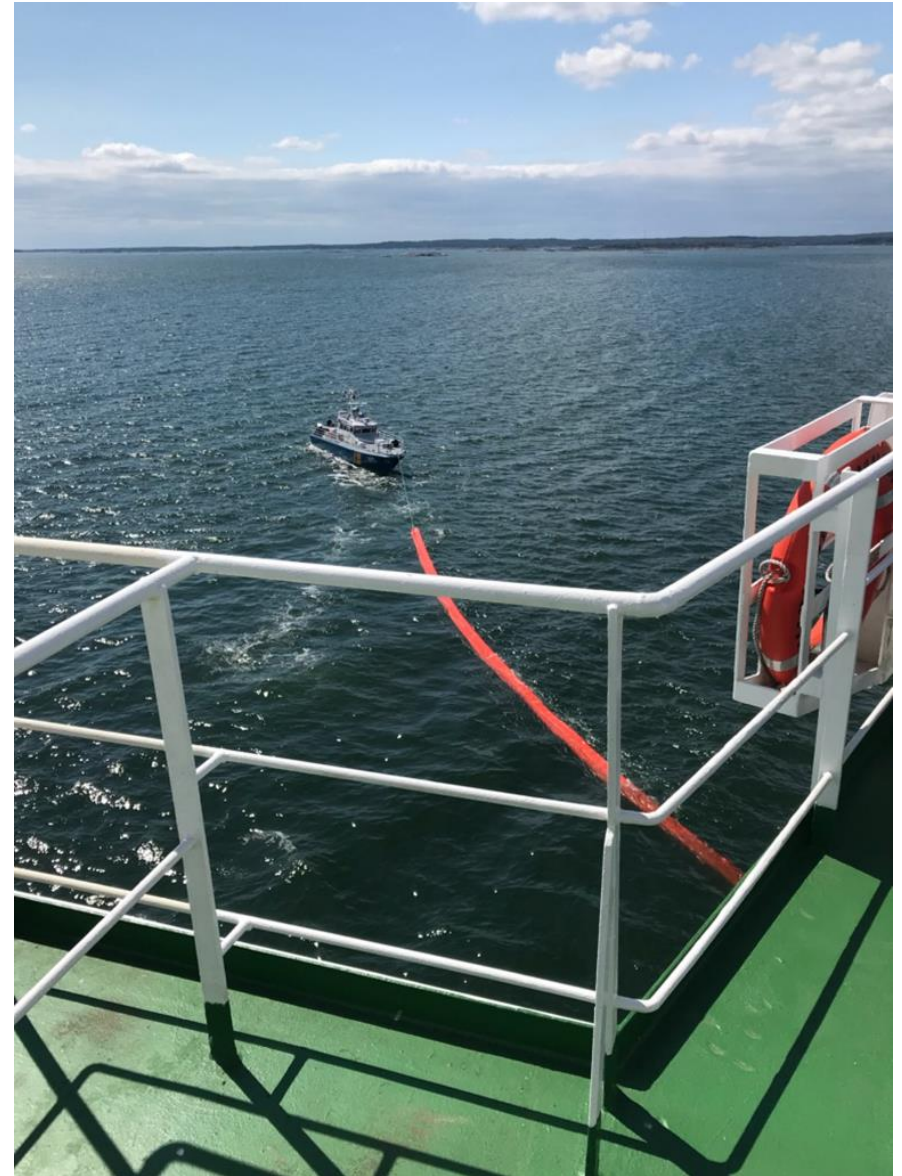
- The first information came 24th July - oil shine was seen on the water, but it was not possible to recover.
- The SCG aircraft was occupied by the ongoing forest fires so a Police helicopter from Gothenburg assisted with aerial footage.
- SCG Rescue leader recommendation was put booms around Makassar

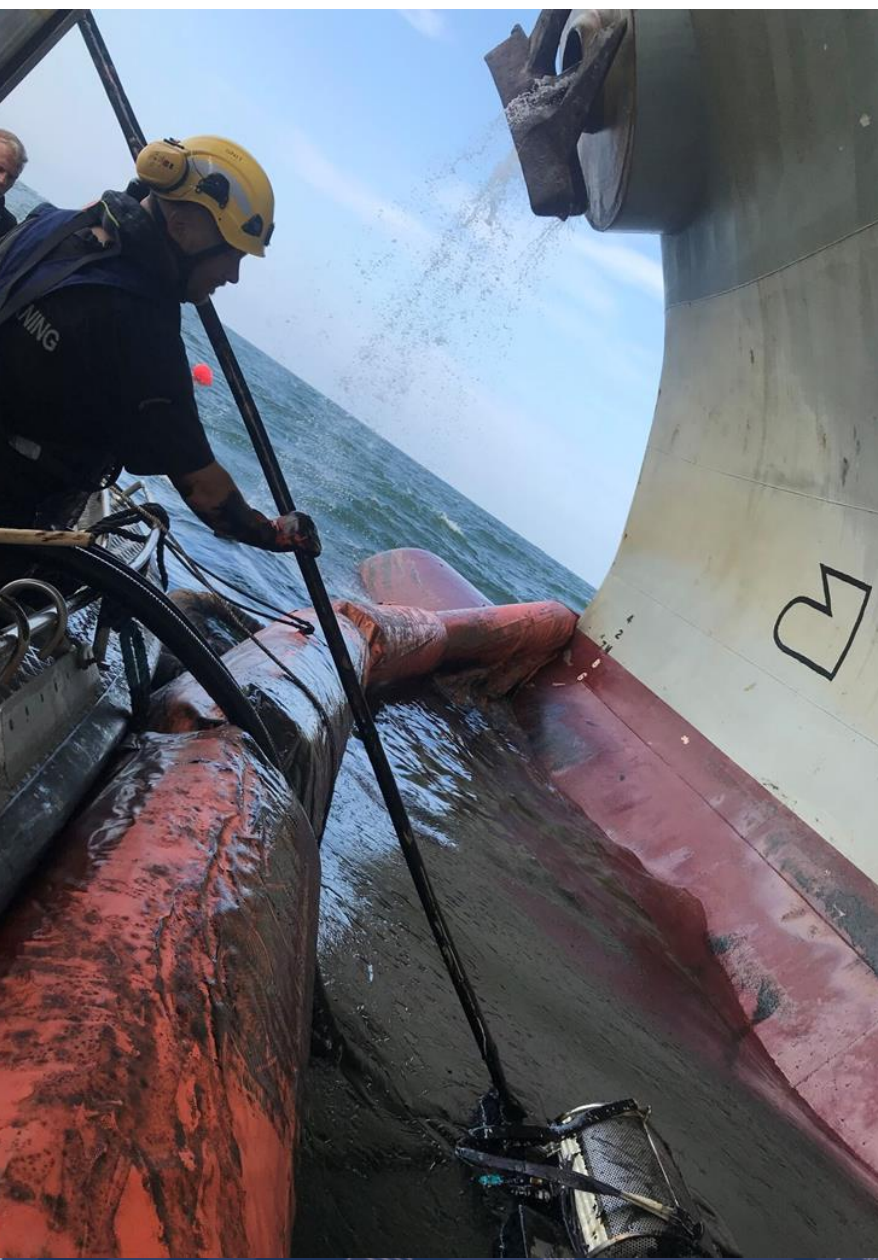
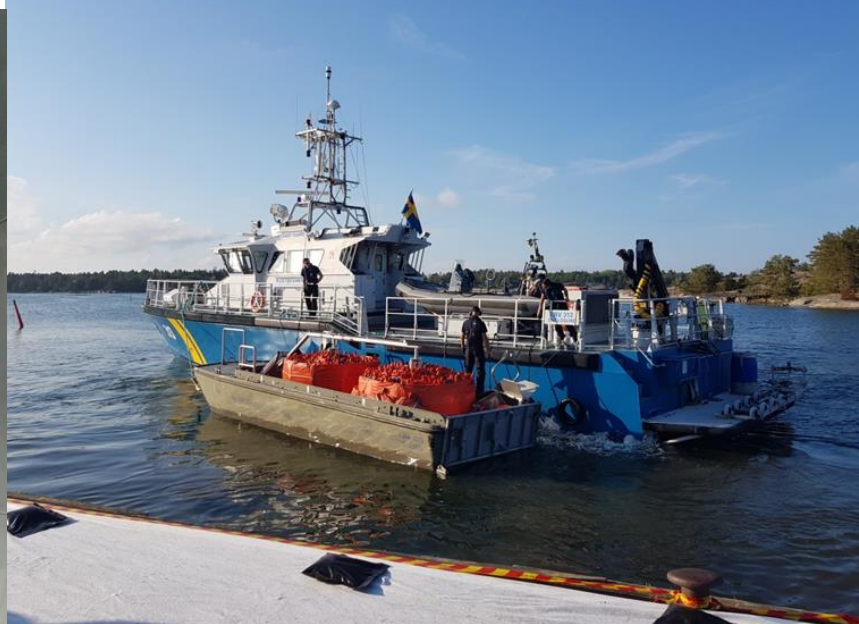
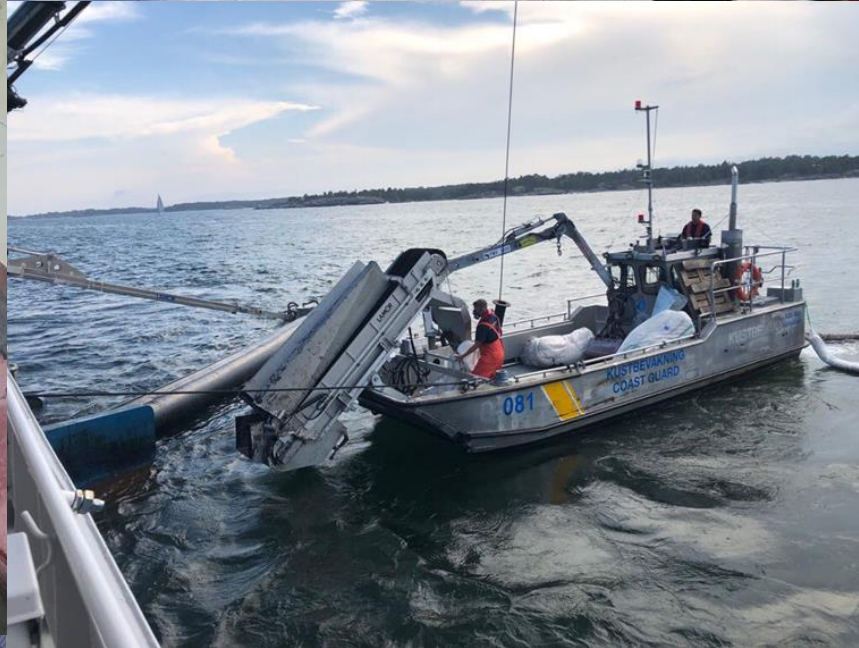
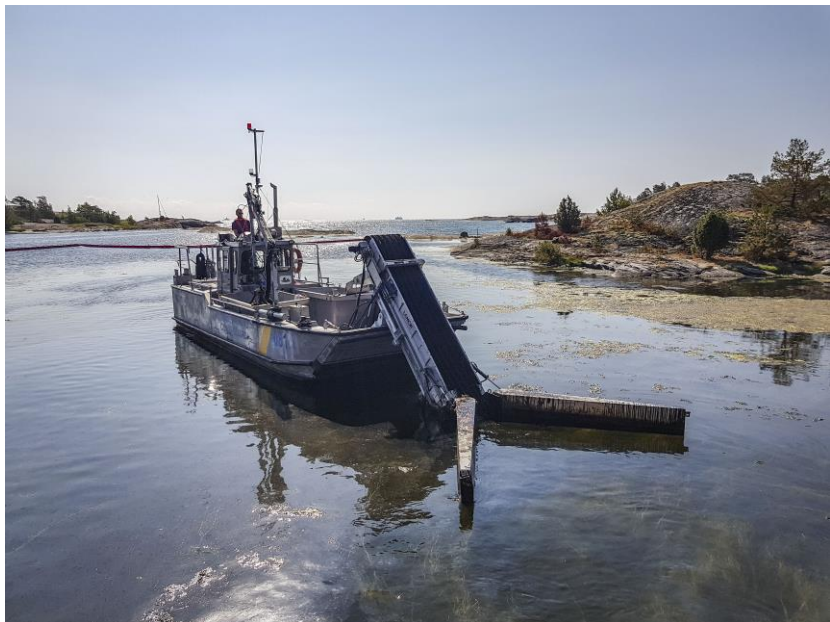
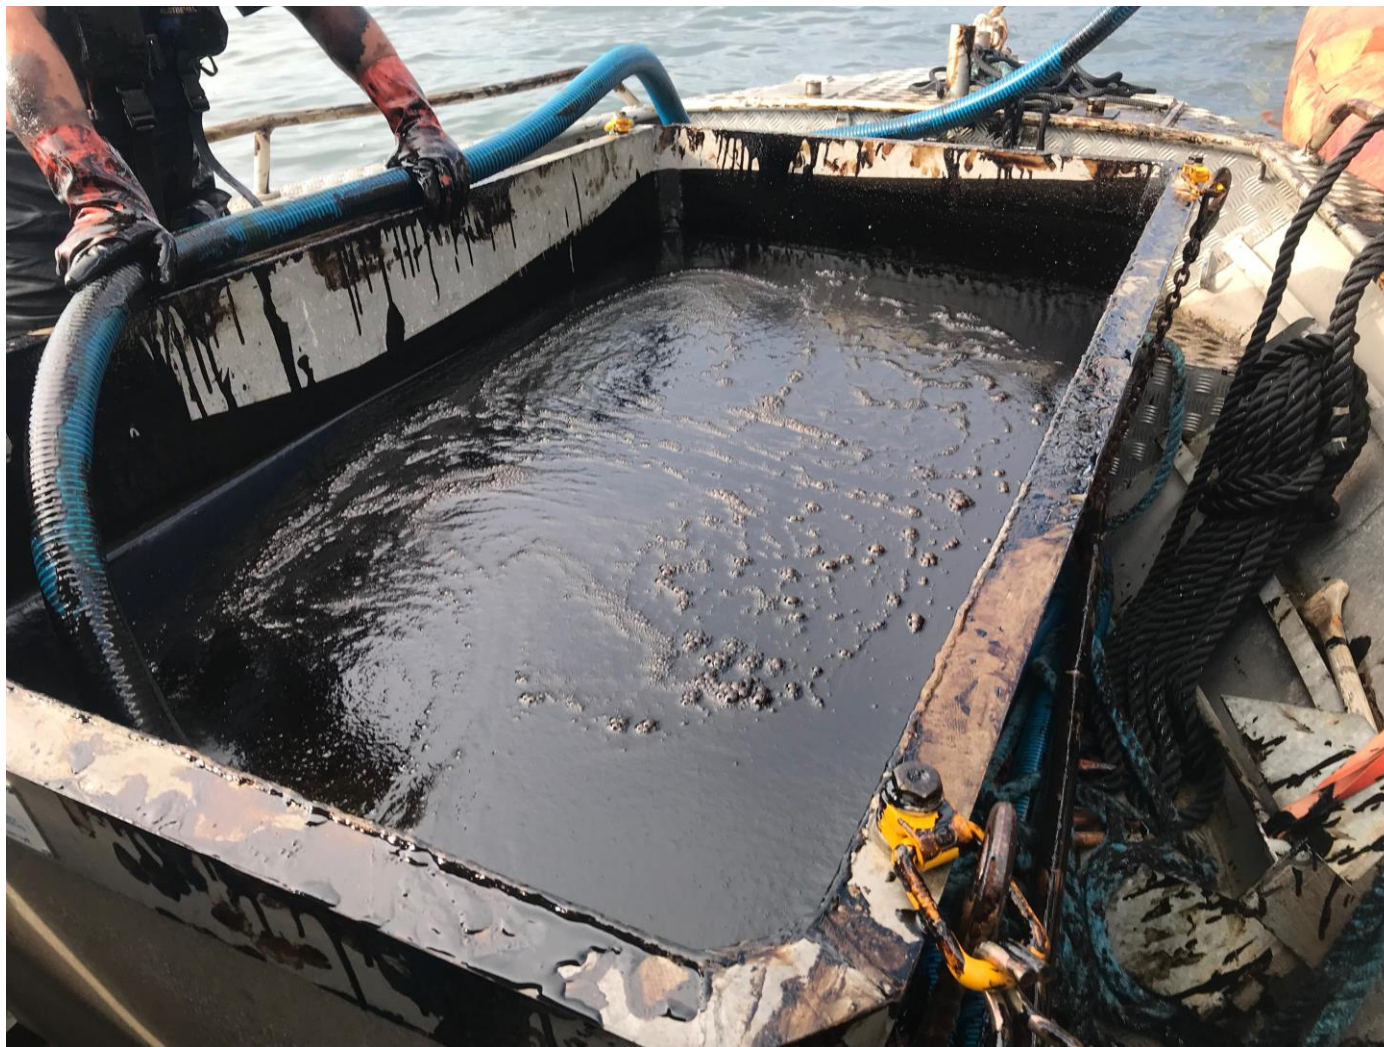
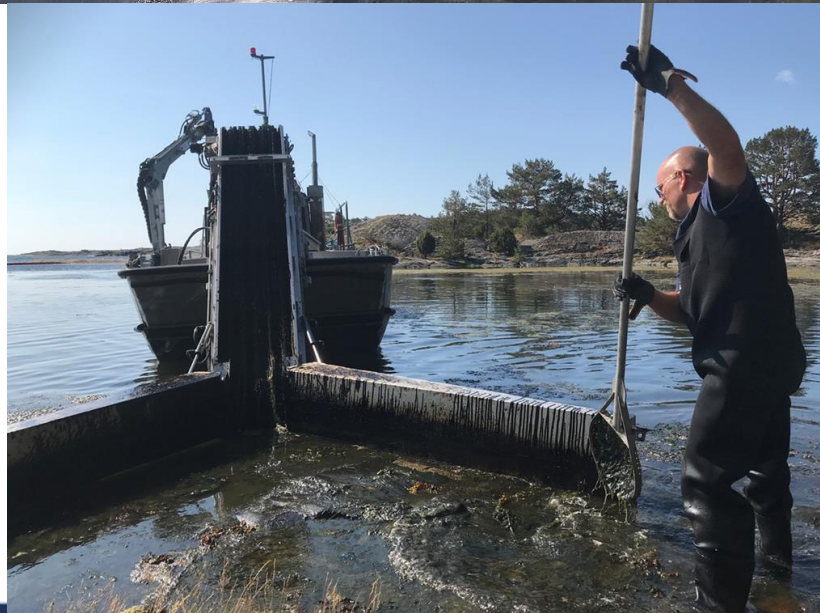
Build-in oil recovery system – chain brush conveyor –

- Good weather conditions
- Water temperature above oils pour point (23°C - 18°C)

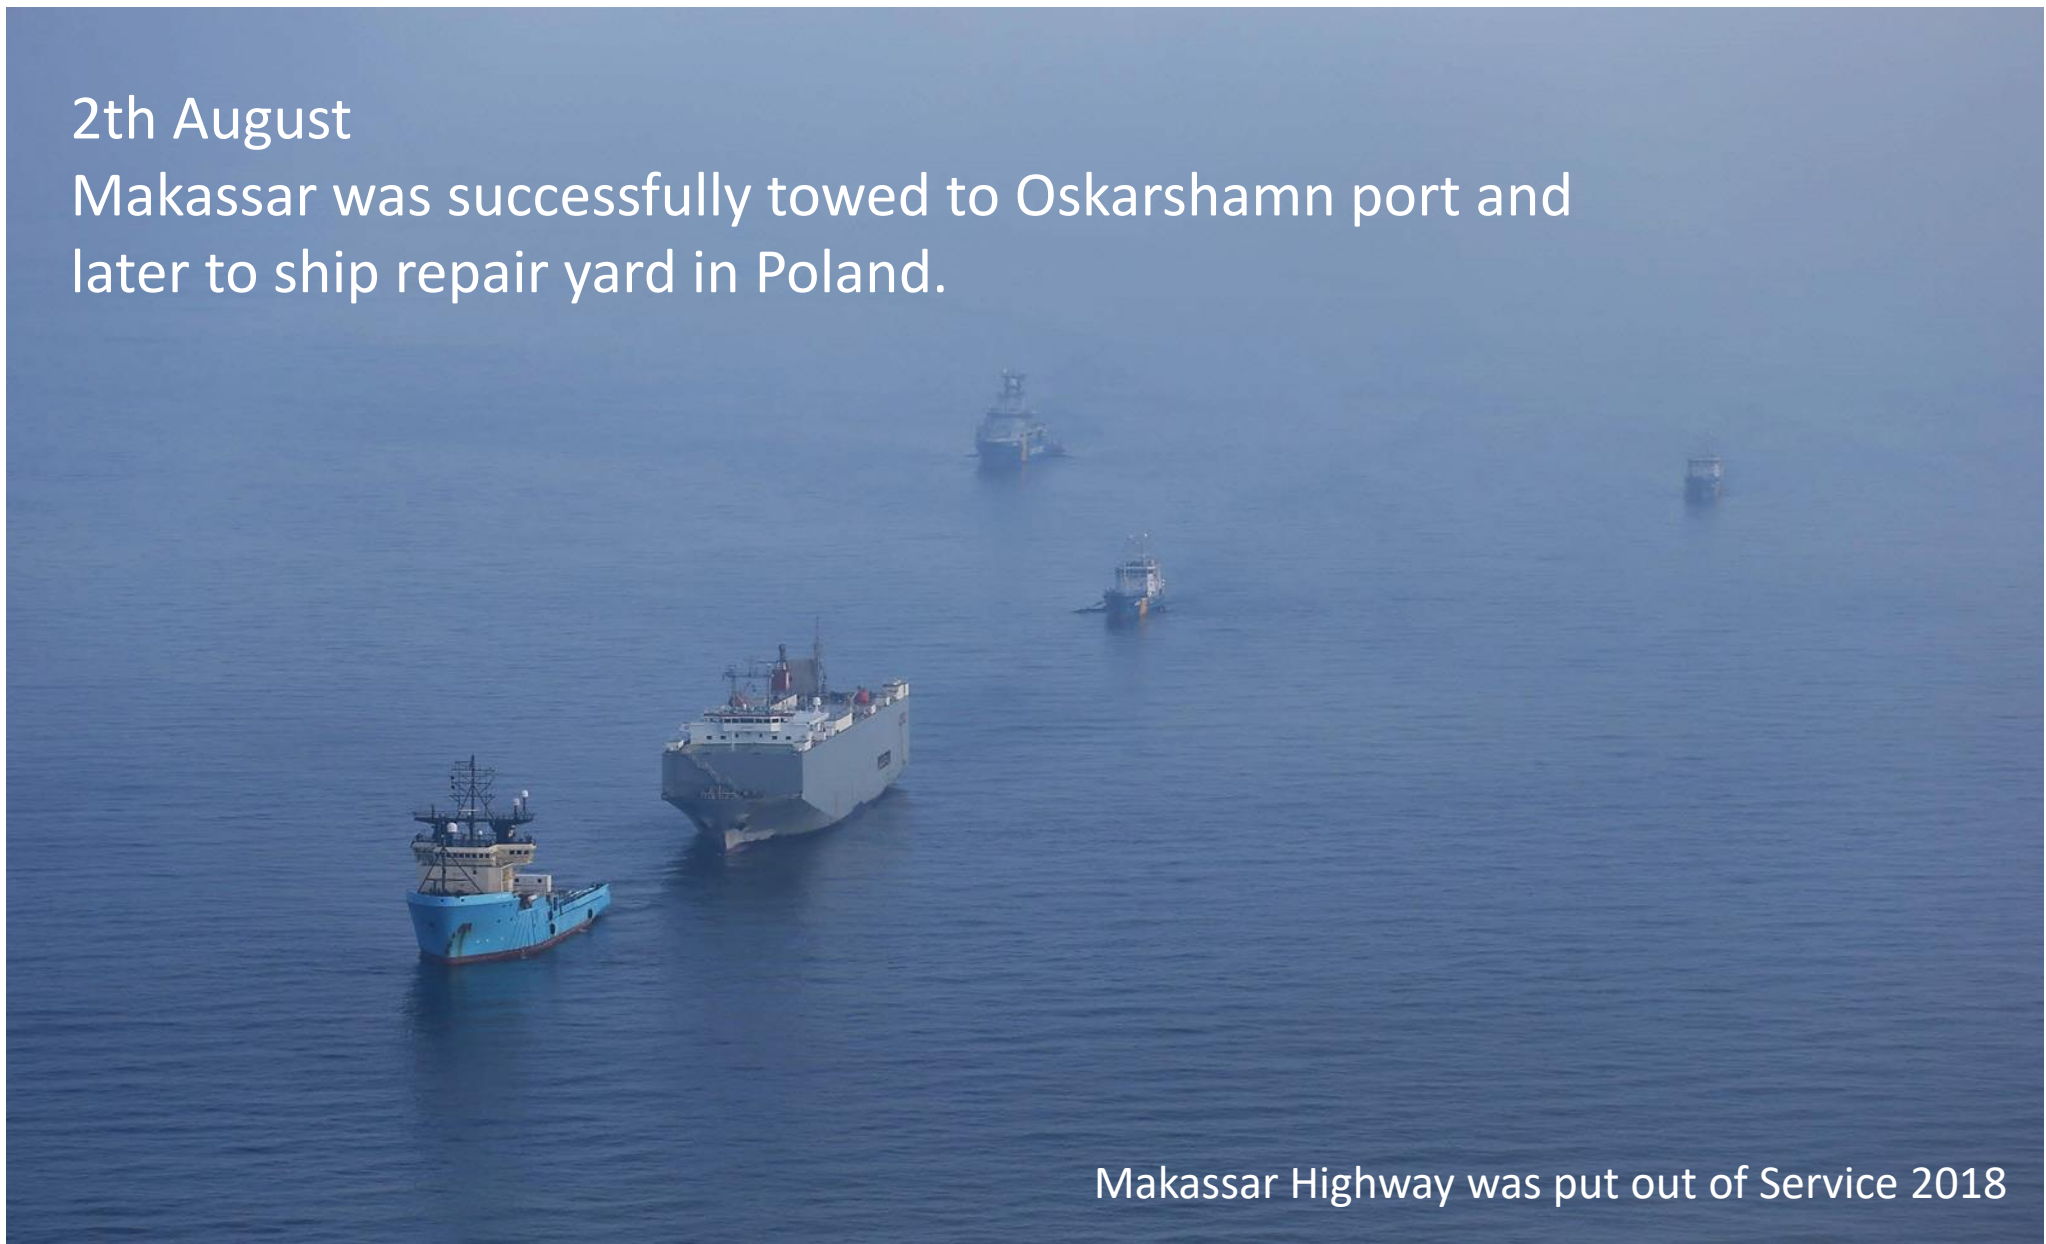
Makassar Highway was put out of Service 2018

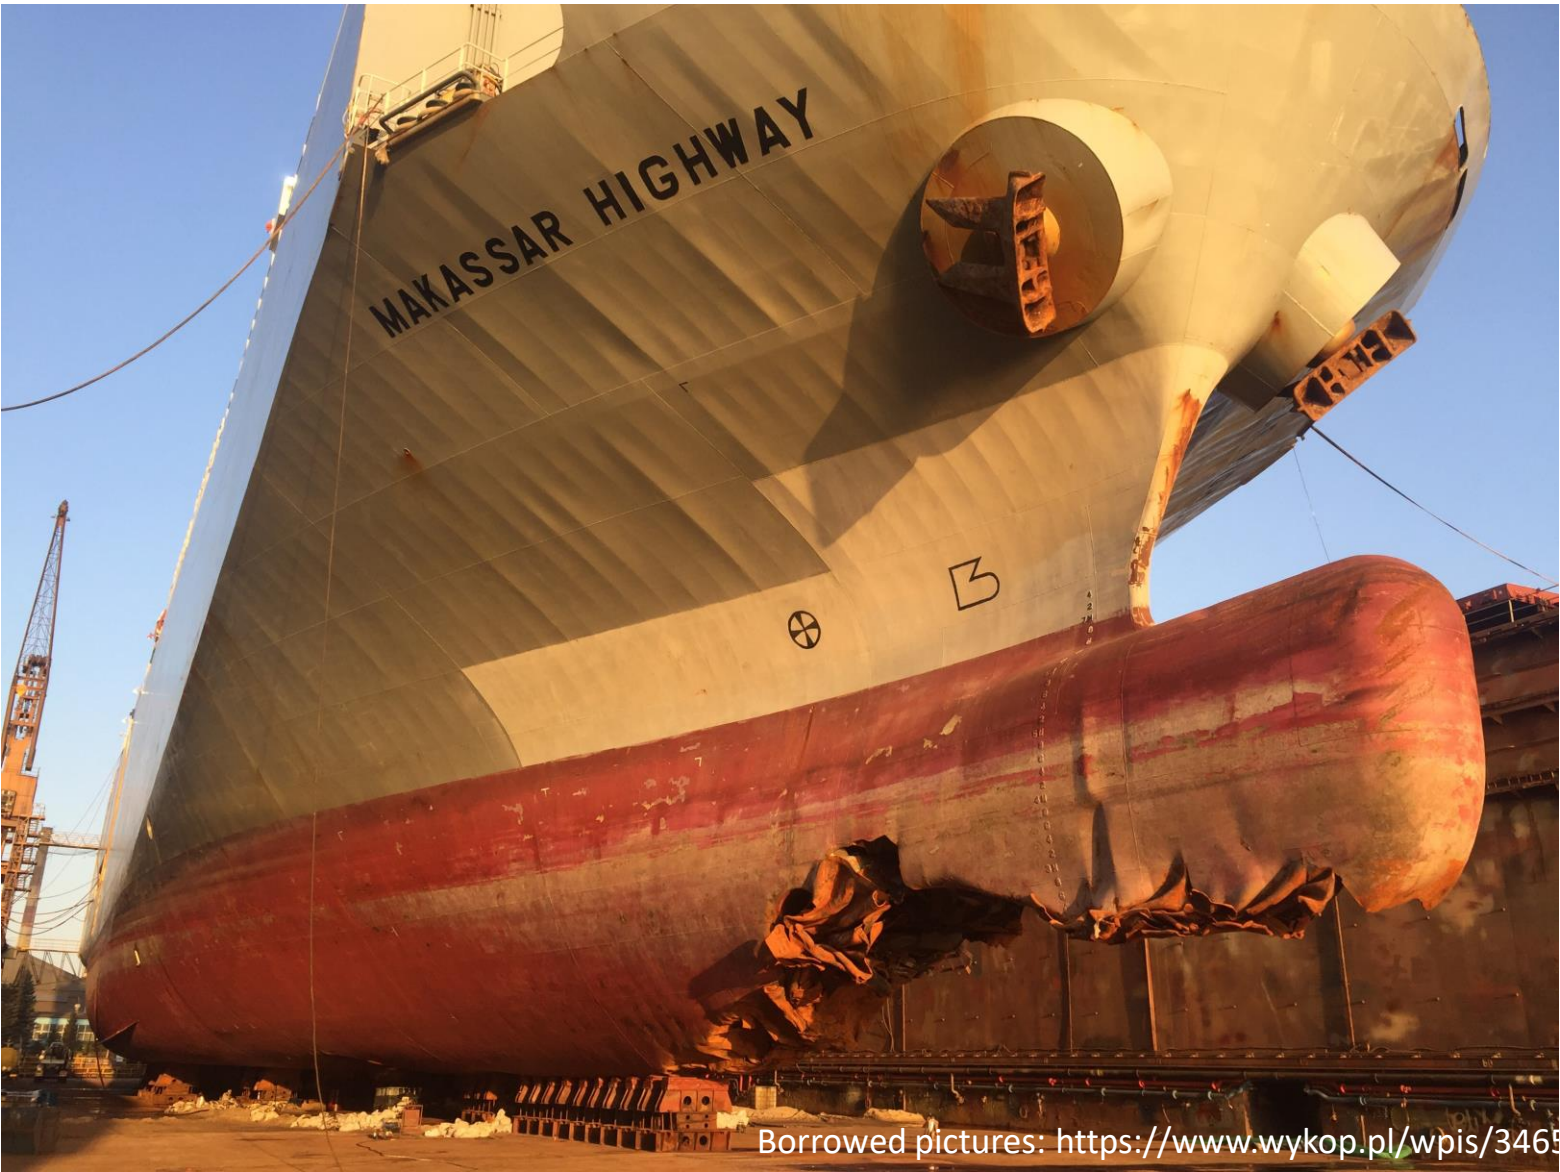
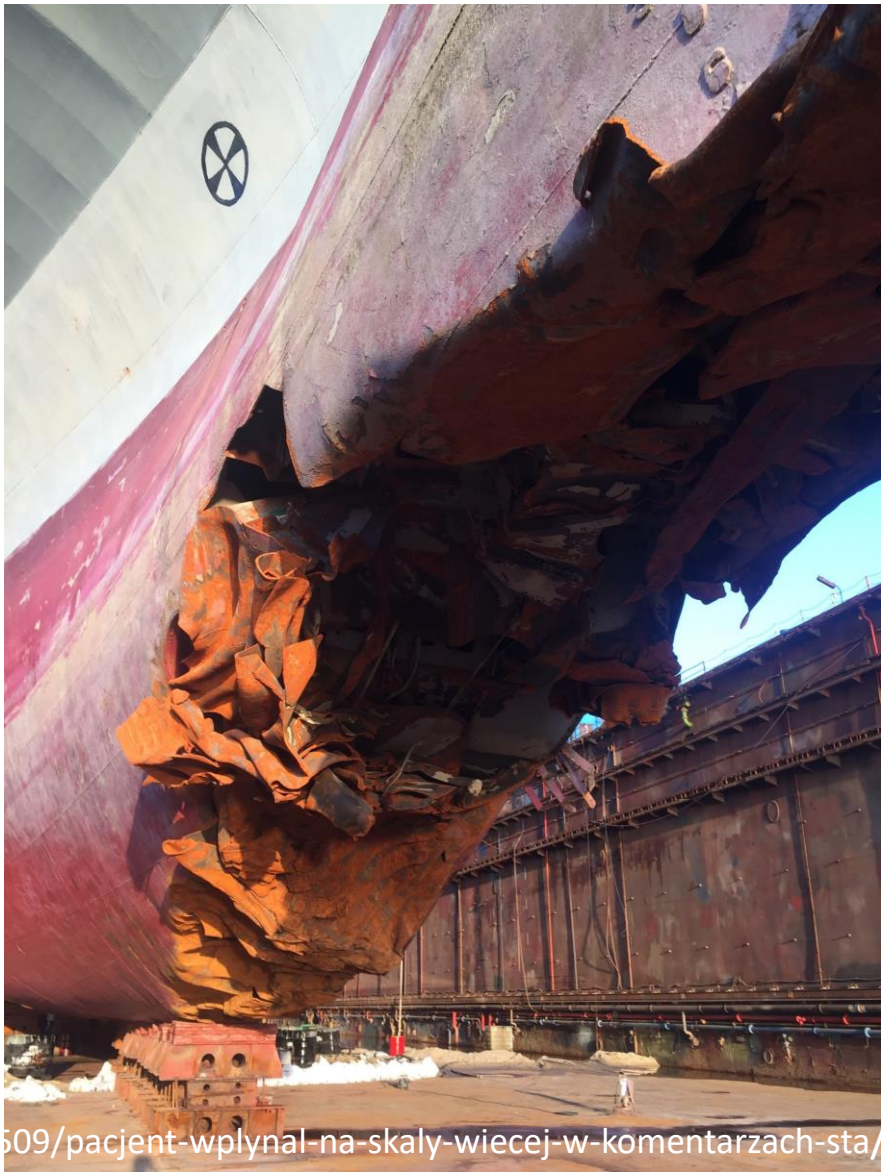
- Holes in the forepeak with water penetration in the front ballast tanks.
- Holes in the bow thruster room.
- Water penetration in at least two tanks.
- Extensive damage on the hull, ships' bulb and its port side.

Makassar was successfully towed to Oskarshamn port and later to ship repair yard in Poland.
