Case Studies in Maltese Ports

Mevric Zammit Ports and Yachting Directorate Authority for Transport in Malta

imaros Spillage during bunkering operation

Case Study 2

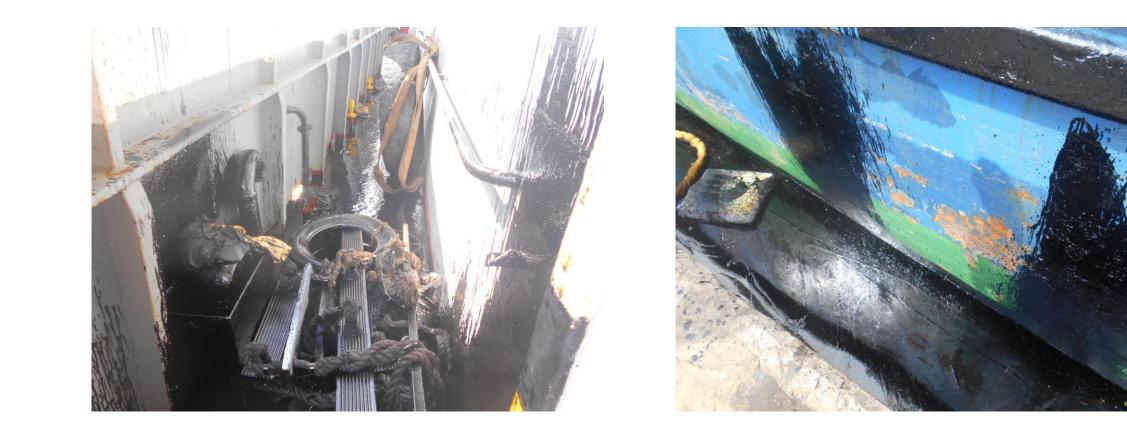
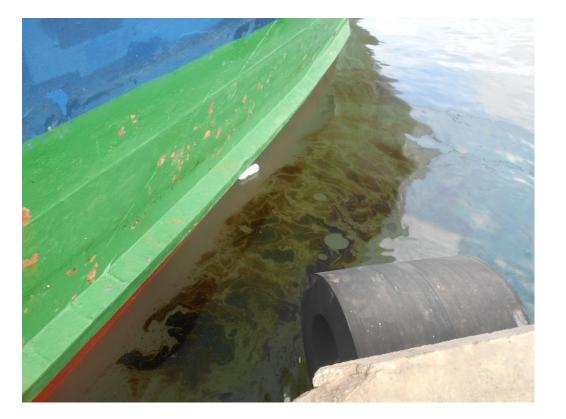
- 2019 Pre IMO 2020
- 2850 DWT General Cargo Ship loaded with cement
- Cargo Operations in the Grand Harbour and receiving bunkers from a local Bunker Barge

- From vessel VLSFO 180 CST
- Requested further information from the bunkering supplier

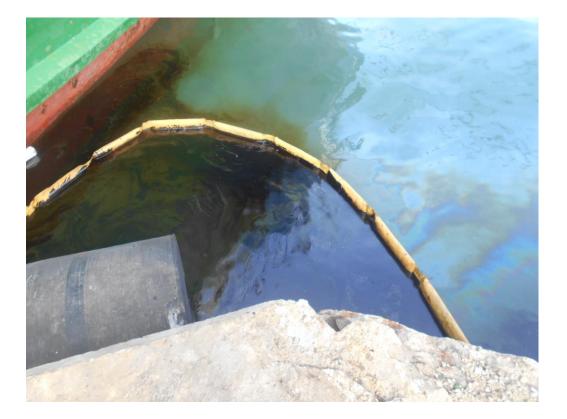
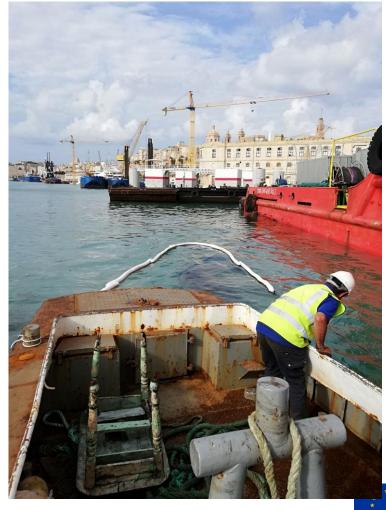
Recovery Operation

- Limited immediate information
- Low viscosity
- Natural dispersion
- No particular recovery issues

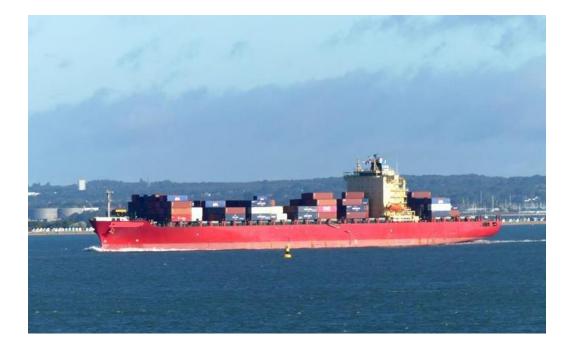
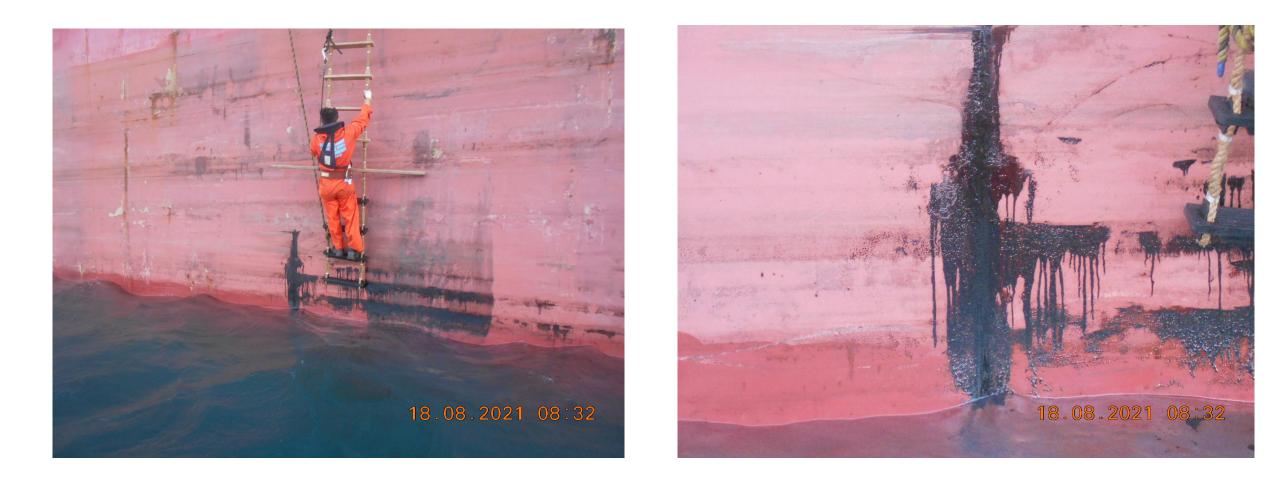
- August 2021
- Malta Freeport
 Terminals Marsaxlokk
 - Port
- Scattered oil

- 3500 TEU Container
 Vessel
- Minor perforation in the outer shell of F.O tank

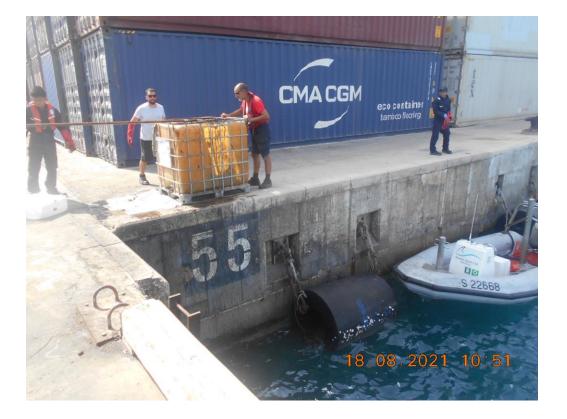
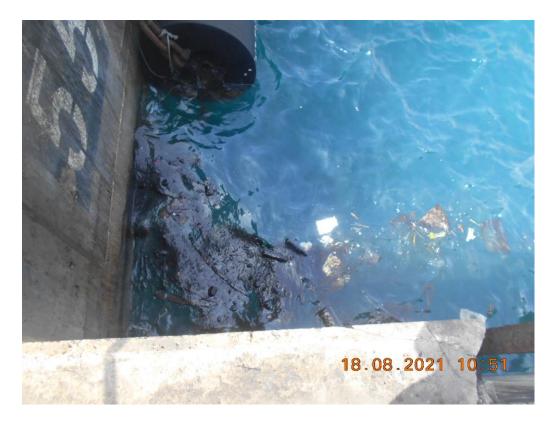
- Information immediately available
- Non-persistent
- Easily recoverable
