KYSTVERKET

Sentralt Styringsdokument for Miljøtiltak ved vraket av U-864

Alternativ 1

Tildekking av vrak og forurenset havbunn

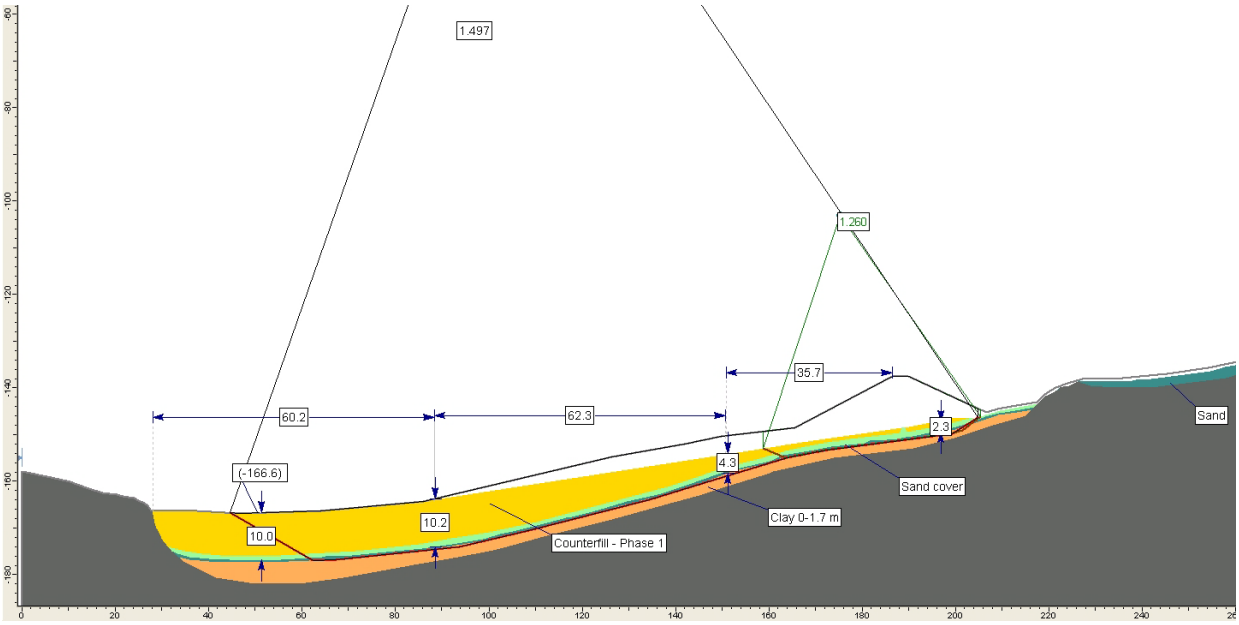
Figure 6-2 shows the results from the stability analyses of Section No 11 in Phase 1. In Phase 1 a 10 m thick counterfill is installed at the bottom of the slope. The thickness is then gradually reduced to 2.3 m at the intersection with the stern wreck part.

Figure 6-2 Stability along Section No 11 Phase 1

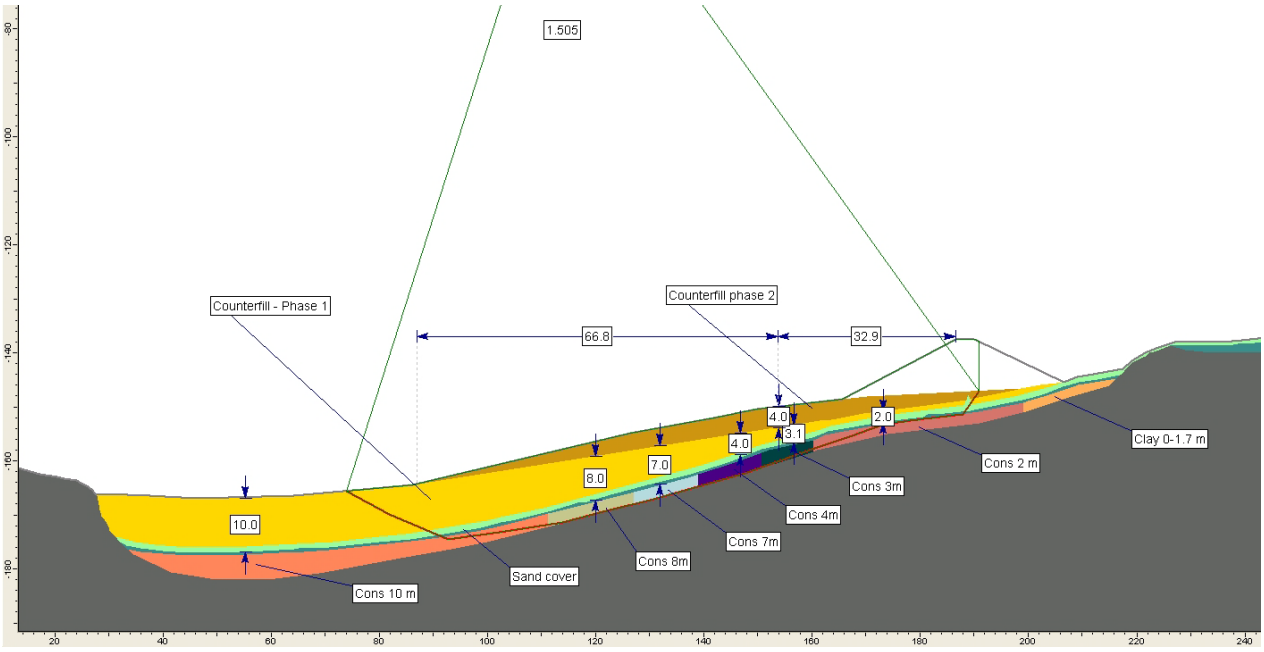
Figure 6-3 shows the result from the stability analyses of Section No 11 in Phase 2. Phase 2 can be installed minimum one year after Phase 1. In Phase 2 additional counterfill is installed with height increasing from 0 to 4 m from the bottom of the slope to the position of the bow part of the wreck. The height is reduced to 0 m at the stern part.

Figure 6-3 Stability along Section No 11 Phase 2

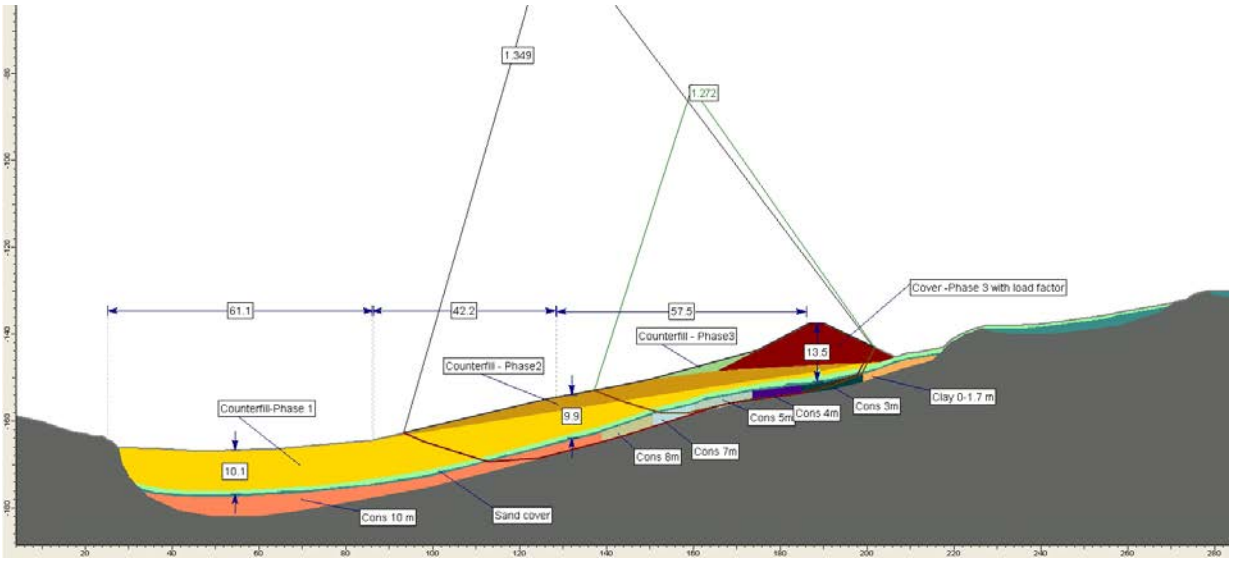
Figures 6-4 shows the results from the stability analyses of Section No 11 in Phase 3. Phase 3 can be installed 1 year after Phase 2. The increased strength due to consolidation is required to achieve sufficient stability. In Phase 3 the cover over the stern part of the wreck can be completed. The stability for rock cover over the stern part is calculated using a load factor of 1.3 on the unit weight if the crushed rock.

Figure 6-4 Stability along Section No 11 Phase 3

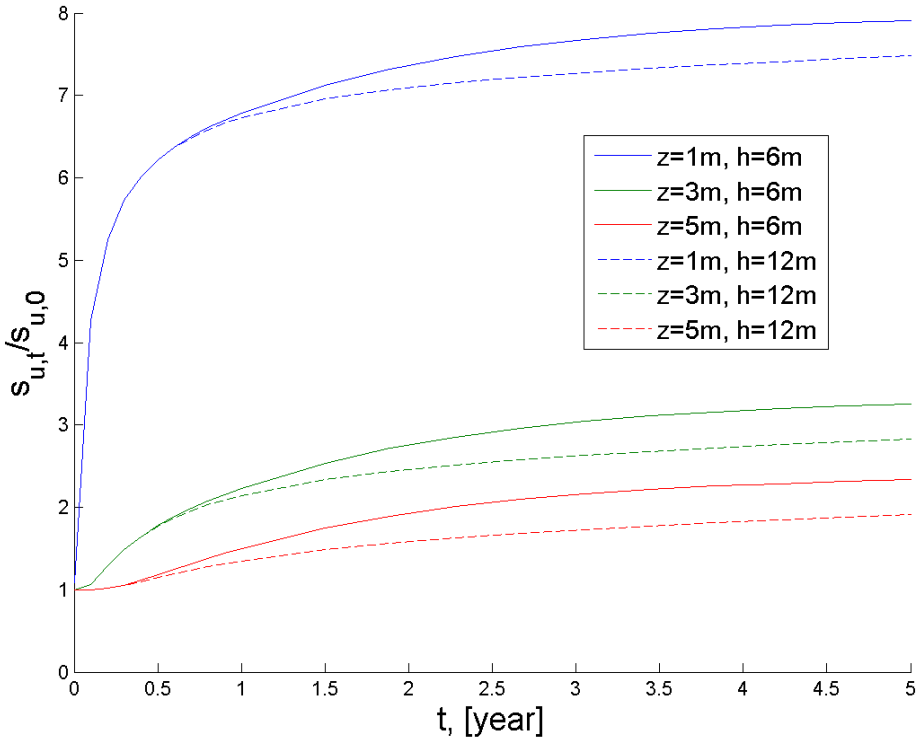
It can be seen that end of consolidation will occur approximately four times faster for the 6 m clay layer than for the 12 m clay layer.

Figure 3.2 Increase in undrained shear strength increase versus time for a clay layers with different thichness consolidated with a load of p=70kPa

Figure 3.2 shows the increase in undrained shear strength as a ratio between undrained shear strength before the filling is constructed ($s_{u,0}$) and the undrained shear strength at a given time after construction of the filling ($s_{u,t}$).

In Figure 3.2 it is shown that the increase in shear strength is relative high for lower depths. The strength increase is practically identical for the two thickness until approximately half a year consolidation. After this point the strength increase is faster for the h=6m thickness.

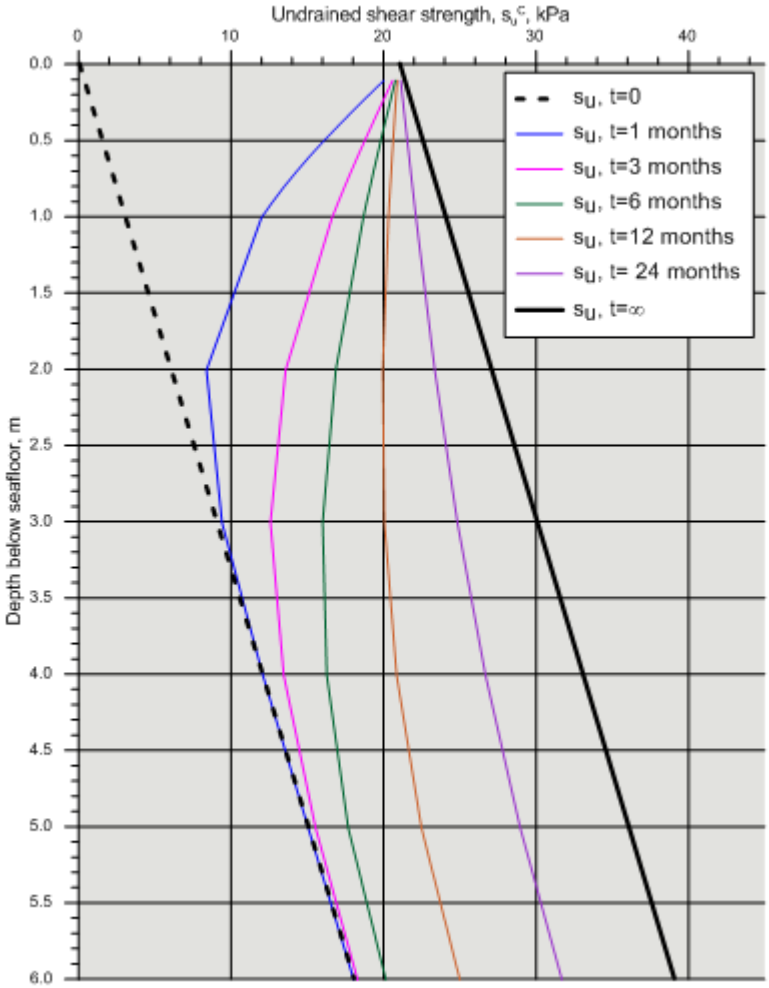
As an example, the effect of consolidation for a clay thickness of h=6m is calculated for different times after construction of the filling. The results are shown in Figure 3.3. The increase in undrained shear strength is large in the upper part of the clay layer and reduces with depth.

Figure 3.3 Undrained compression shear strength for a clay layer with a thickness of h=6m as a function of consolidation time, for a consolidation load of p=70kPa.

It is recommended to consider a potential undrained shear strength increase due to consolidation in a detailed design of a possible filling. Here, the effect of consolidation during construction of the filling and the load spread of the filling should be included.

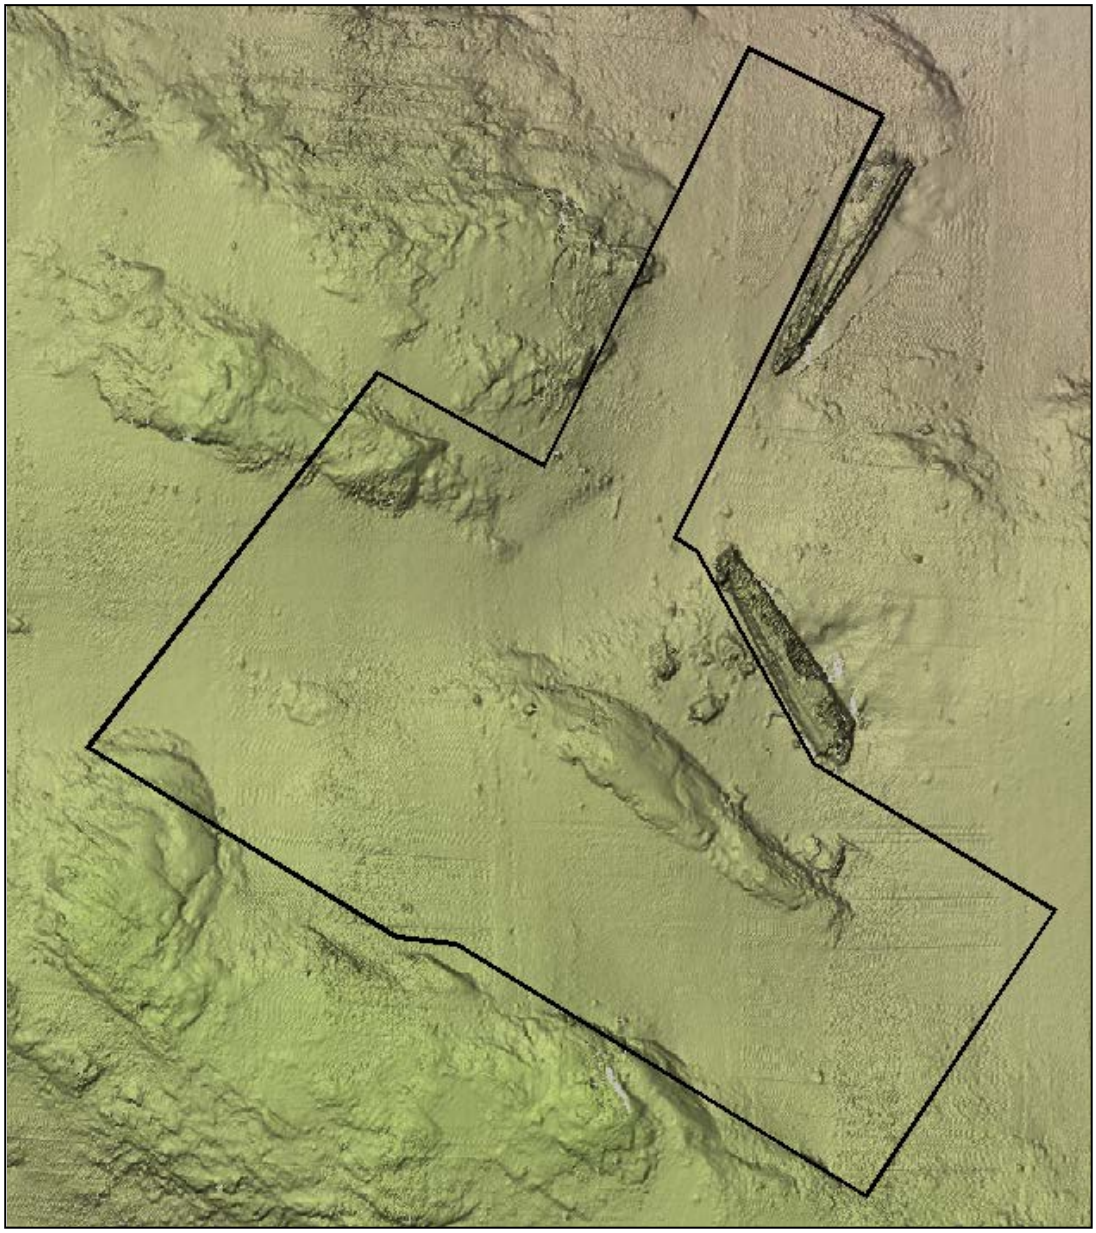
The survey was conducted over the area shown in Figure 3.4. A number of small new targets were located although none were considered to be significant in terms of Hg contamination or identification of the missing middle section. Targets previously identified during Phase 1 and 2 were found to be in the same locations and in a similar condition to that previously reported.

Figure 3.4 Clear Zone established during High Definition video survey

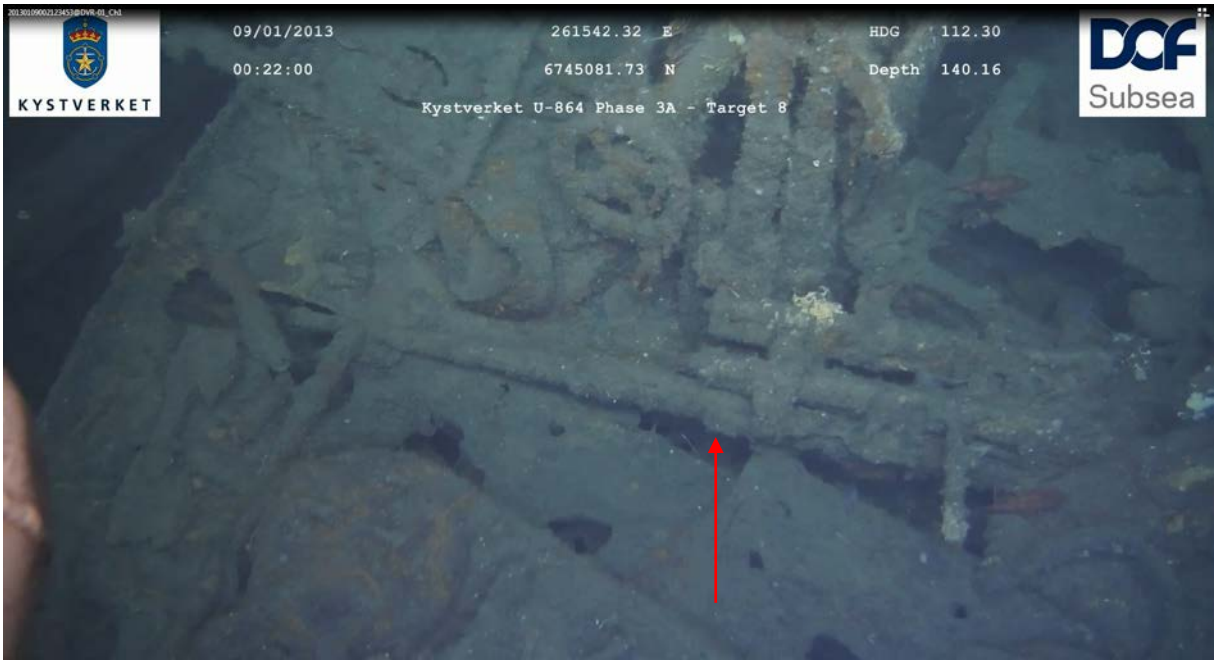
As the main gun is clearly visible on the forward casing, and the aft gun is located on the aft part of the "winter garden" (Figure 3 to 5), the conclusion is that two of the guns have been identified on the wreck and the last one on the adjacent debris. This is an important finding as it proves that all major parts of the top of the superstructure have been located.

Figure 5 **One of the two Single barreled guns (red arrow), from the conning tower**

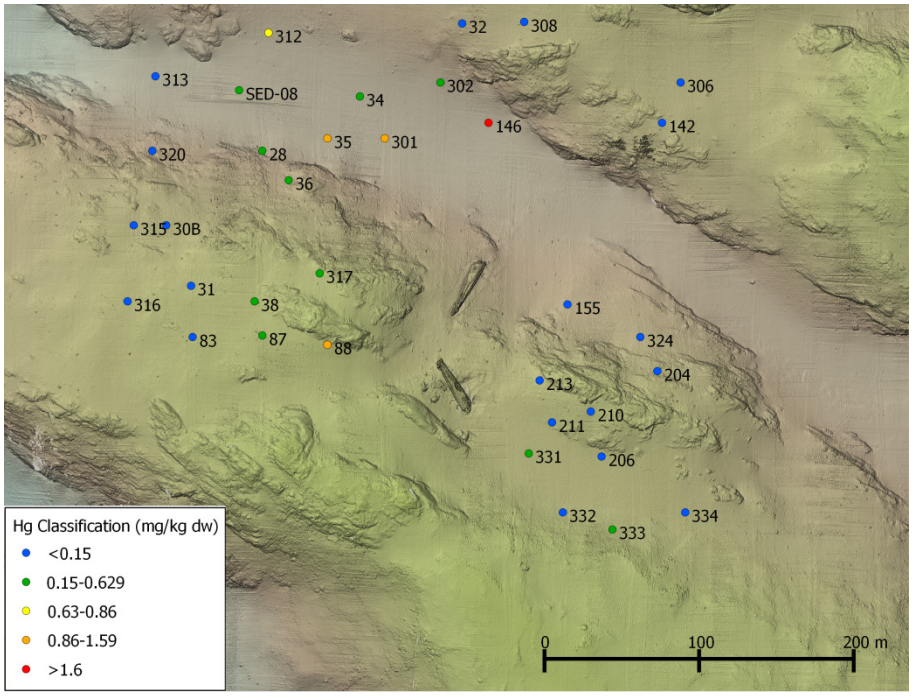
Results of the mercury analysis performed after the survey are presented in Table 3, Figure 1 and Figure 2. Some sediment stations north and west of the submarine were slightly more polluted with mercury than in 2006. This is in accordance with the direction of the water current which has been found to go in a north western direction (Uriansrud et al. 2006). On station 146 the concentration of mercury was substantially higher (Class V) compared to 2006 (Class II). The new samples taken south and west of the submarine were in Class I and II and had not increased since 2006. The results of mercury measurements for all years are shown in Figure 2. Data from earlier investigations have been taken from Skei (2003), Uriansrud et al (2005) and Uriansrud et al (2006). This gives an updated picture of the polluted area around the wreck of U-864.

Figure 1. Concentrations of mercury in the surface sediment (0-2 cm) near the wreck of U-864 outside Fedje. The samples were taken in January 2013. The results are classified according to the classification system of the Norwegian Climate and Pollution Agency (Bakke et al. 2007).

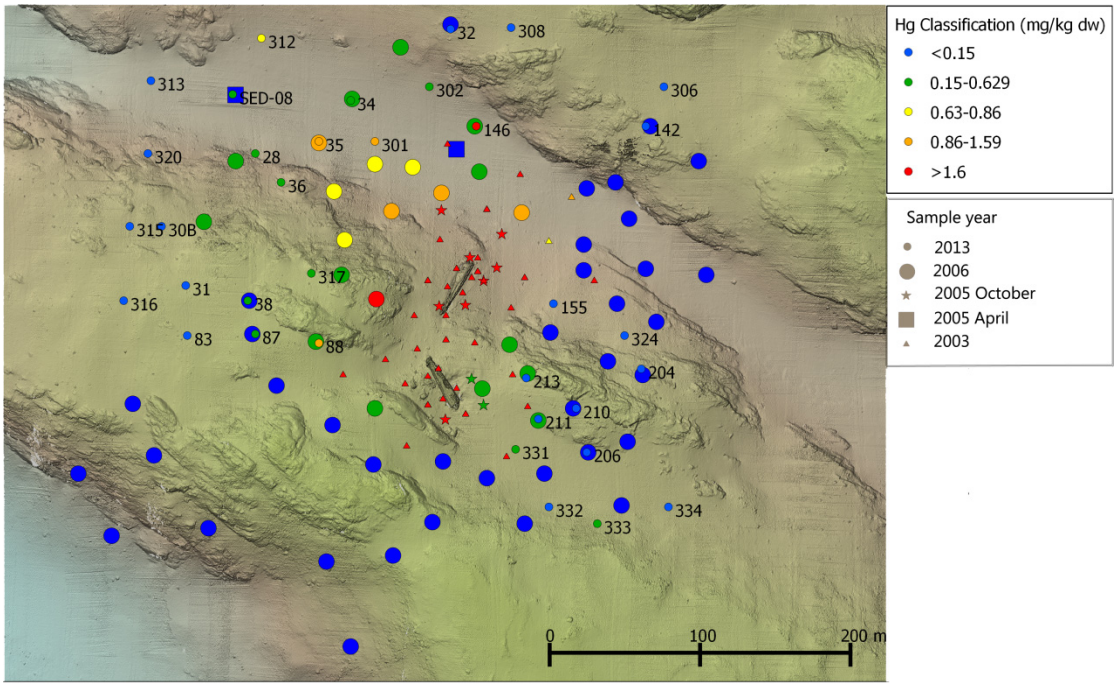
Figure 2. Concentrations of mercury in the sediment around U-864 outside Fedje. Results for all years are presented on the map. The results are classified according to the classification system of the Norwegian Climate and Pollution Agency (Bakke et al.2007). Because of the revision of the classification system, some of the observations may have been classified one class higher (worse) than they were in previous reports.

Some sediment stations north and west of the submarine were slightly more polluted with mercury than in 2006. This is in accordance with the direction of the water current which has been found to go in a north western direction (Uriansrud et al. 2006). On station 146 the concentration of mercury was substantially higher (Class V) compared to 2006 (Class II). The new samples taken south and west of the submarine were in Class I and II and had not increased since 2006.

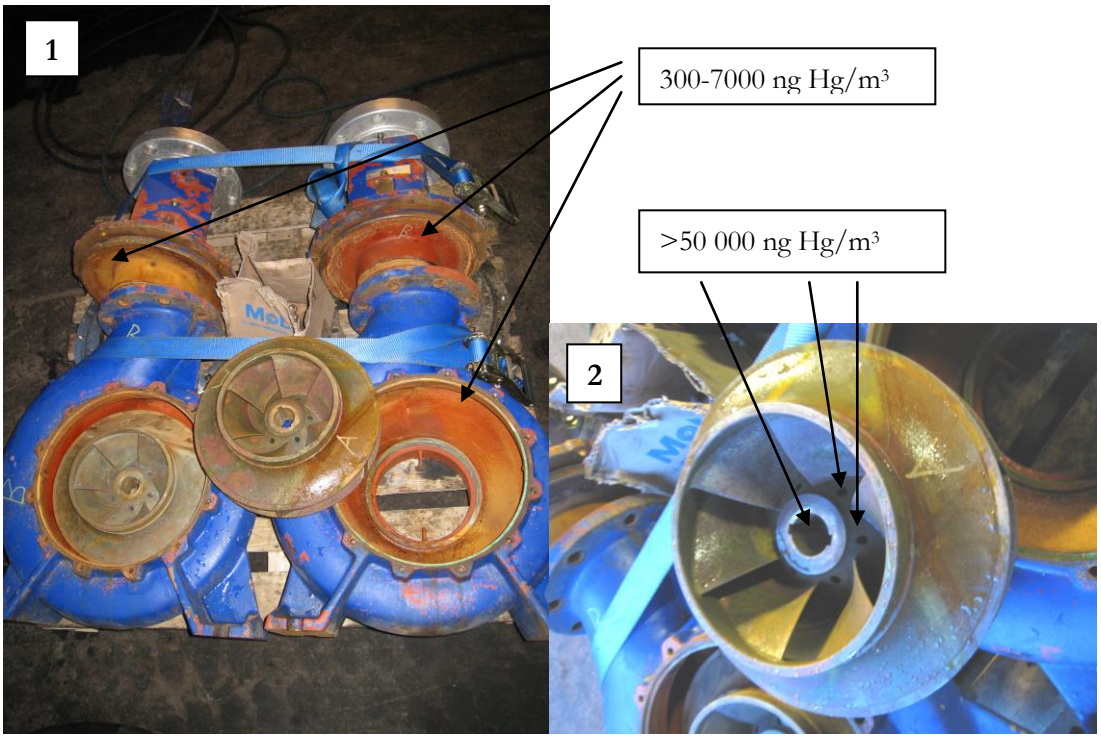
Målinger av kvikksølv ble utført med en Lumex RA-915 portabel kvikksølvanalysator. Målinger av kvikksølvdamp fra pumpene ble gjort første gang kl 8:00. Det ble med en gang målt høye konsentrasjoner av kvikksølv på den midtre delen av begge pumpene, i midten og i hull rundt (se bilde 2).

Bilde 1. Pumpene som ble undersøkt for kvikksølvforurensning.
Bilde 2. Stedene på pumpene hvor det ble påvist høye kvikksølvkonsentrasjoner.
