SWEDISH COAST GUARD

Alpine Penelope Incident - 13 april 2022

Oil spill during Bukering operation

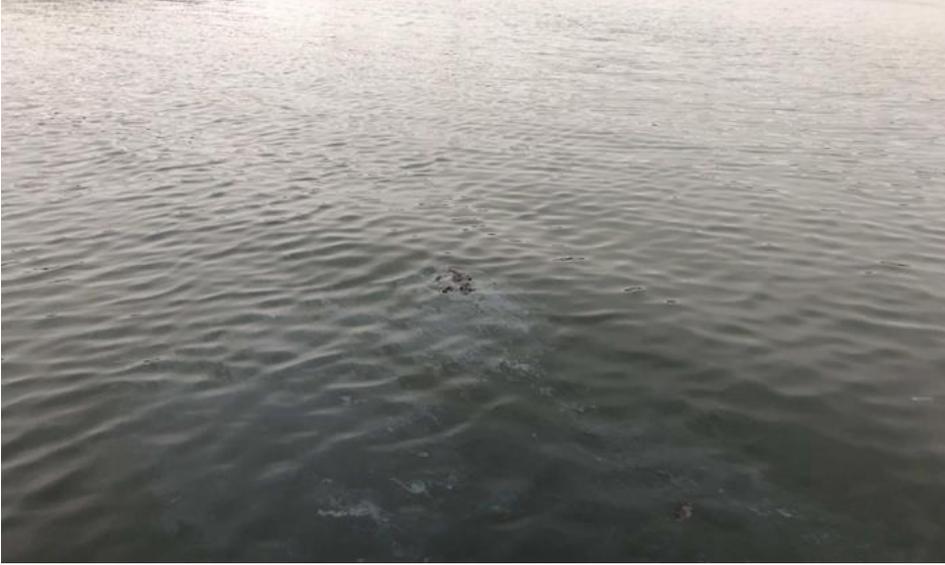
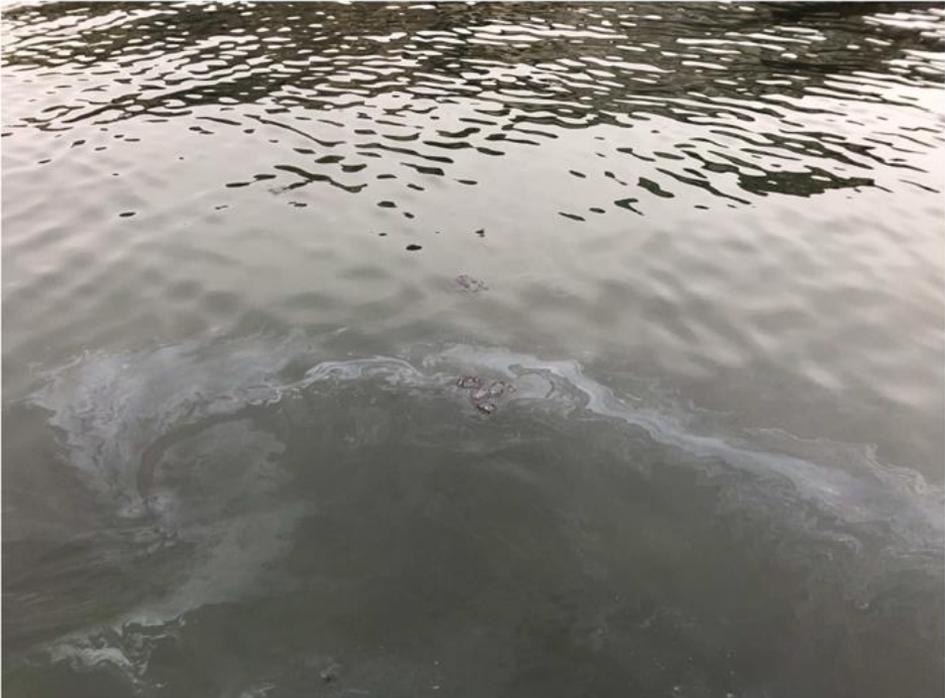
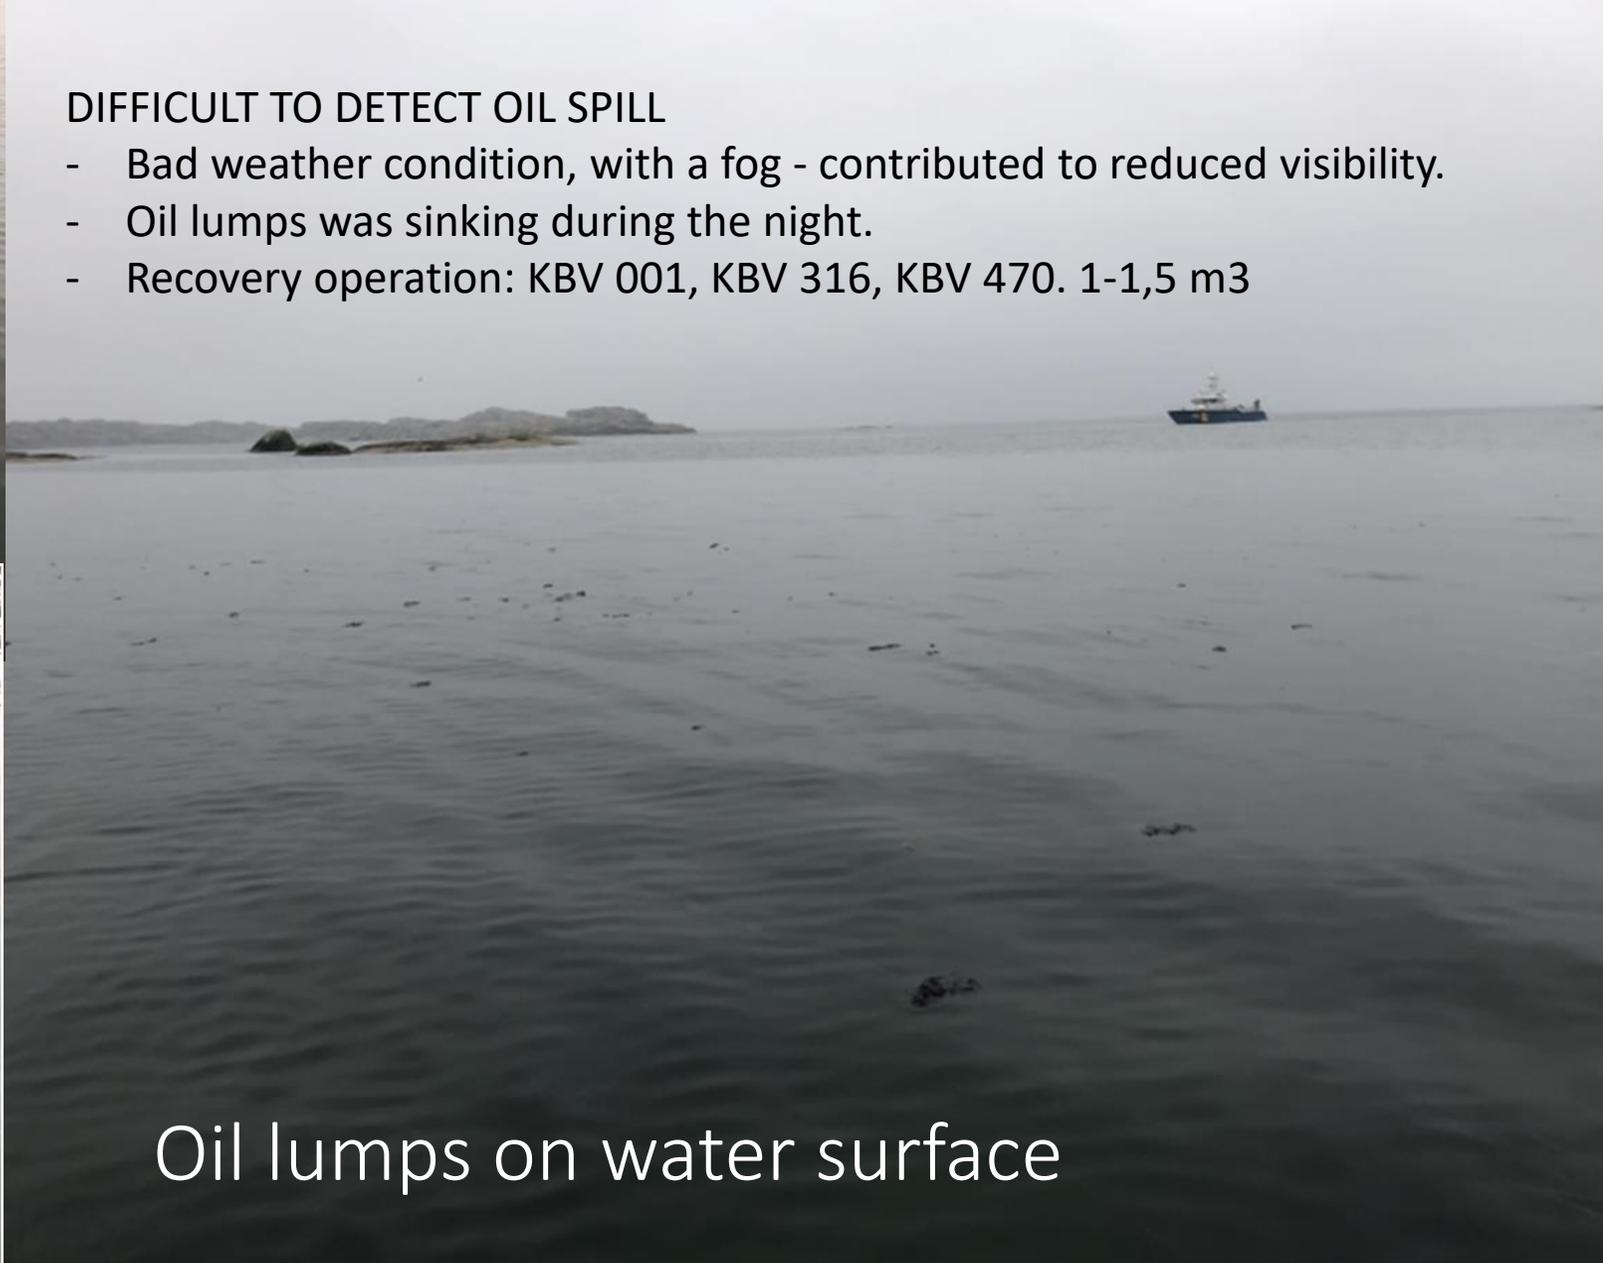
DIFFICULT TO DETECT OIL SPILL

- Bad weather condition, with a fog - contributed to reduced visibility.
- Oil lumps was sinking during the night.
- Recovery operation: KBV 001, KBV 316, KBV 470. 1-1,5 m³

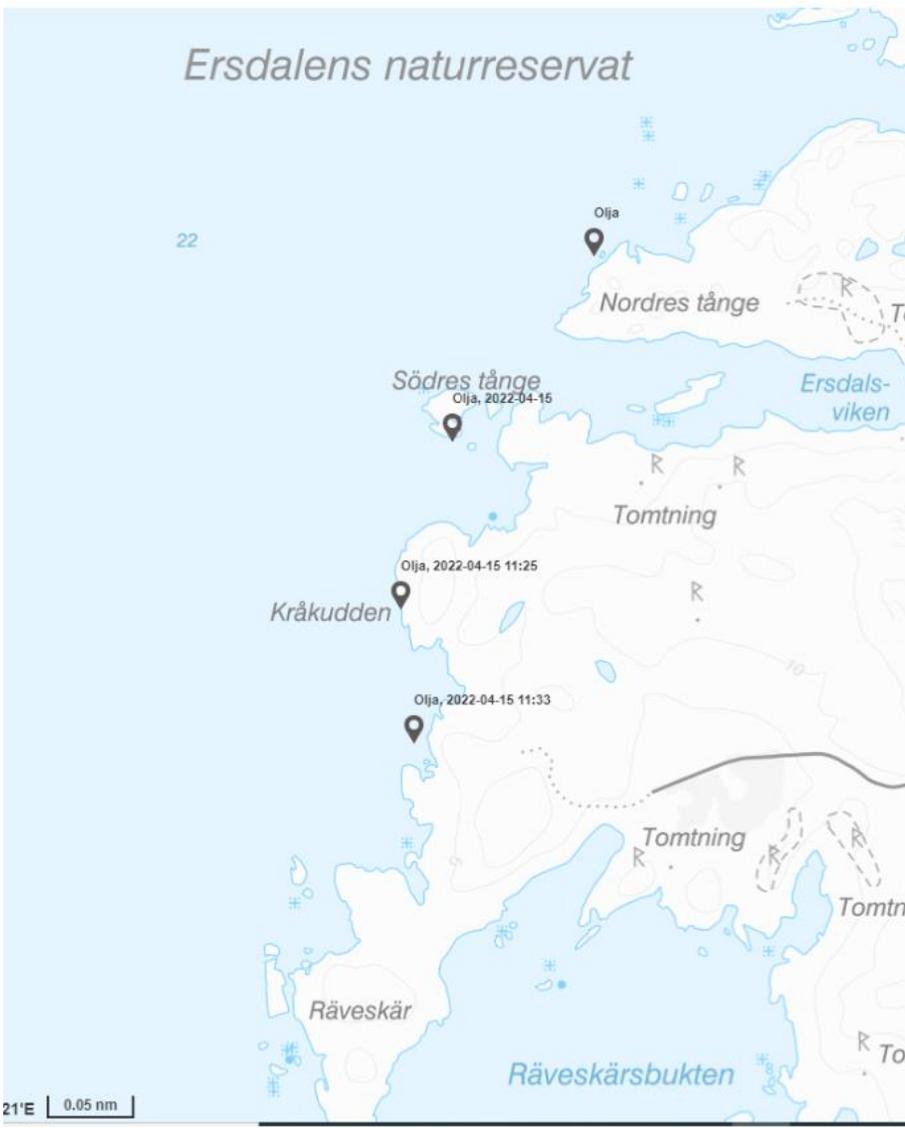
Oil lumps on water surface

affected municipalities started clean-up operation
